U.S. Chemical Safety and Hazard Investigation Board

AL Solutions, Inc., New Cumberland, WV Metal Dust Explosion and Fire

December 9, 2010

No. 2011-3-I-WV

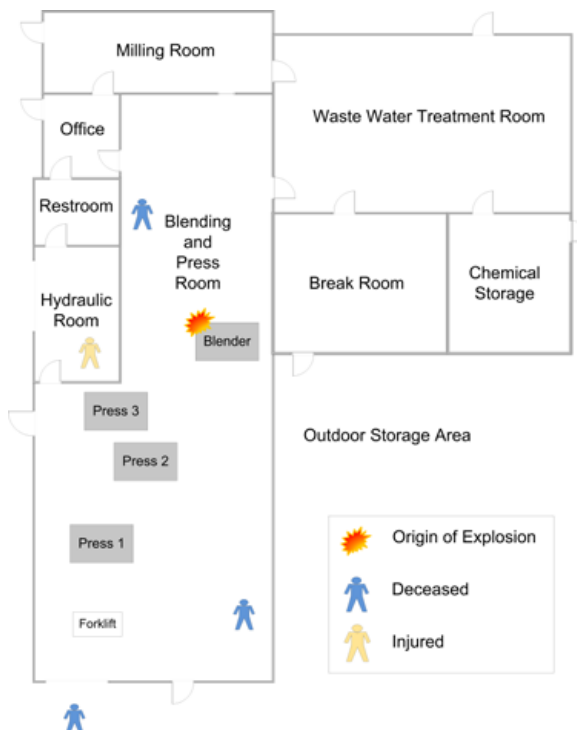
FIGURE 6

Main Production Building Layout, Likely Initiation Point of the Incident, and Worker Injury and Fatality Sites
