Final Public Meeting – July 16, 2014

**AL Solutions, Inc.
Metal Dust Explosion**

New Cumberland, West Virginia

December 9, 2010

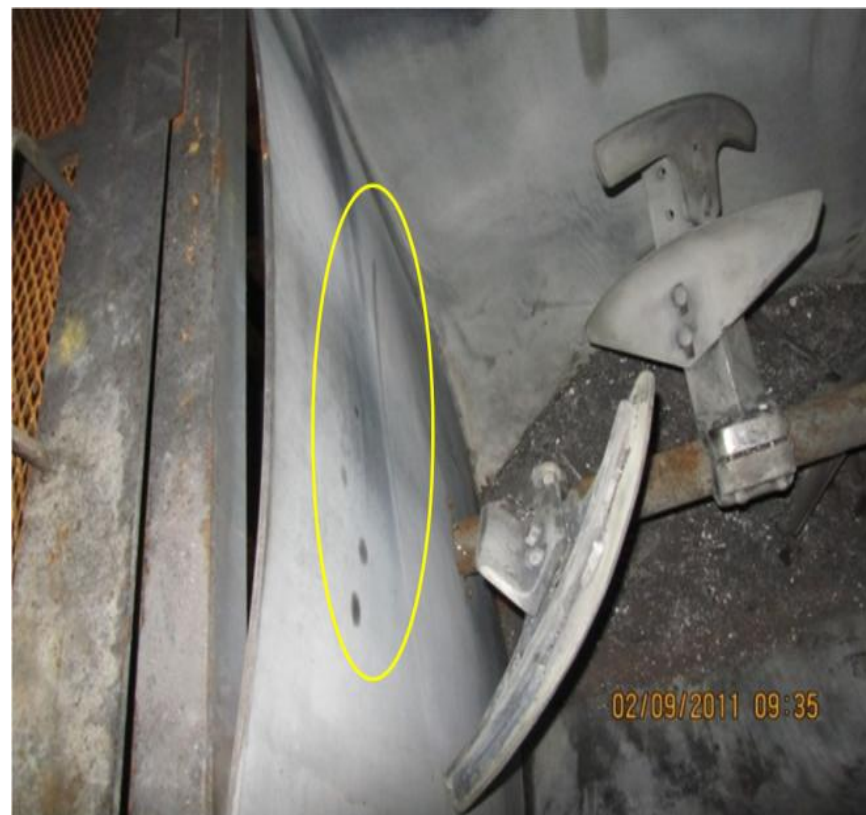
Likely Ignition Point

- Metal blender blades impacted metal blender walls for weeks prior to incident
- Friction likely ignited zirconium in blender

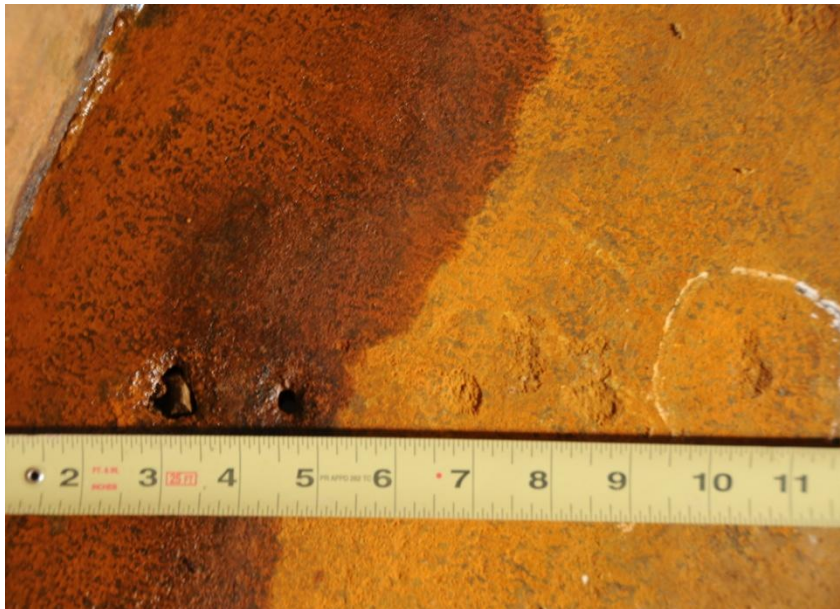
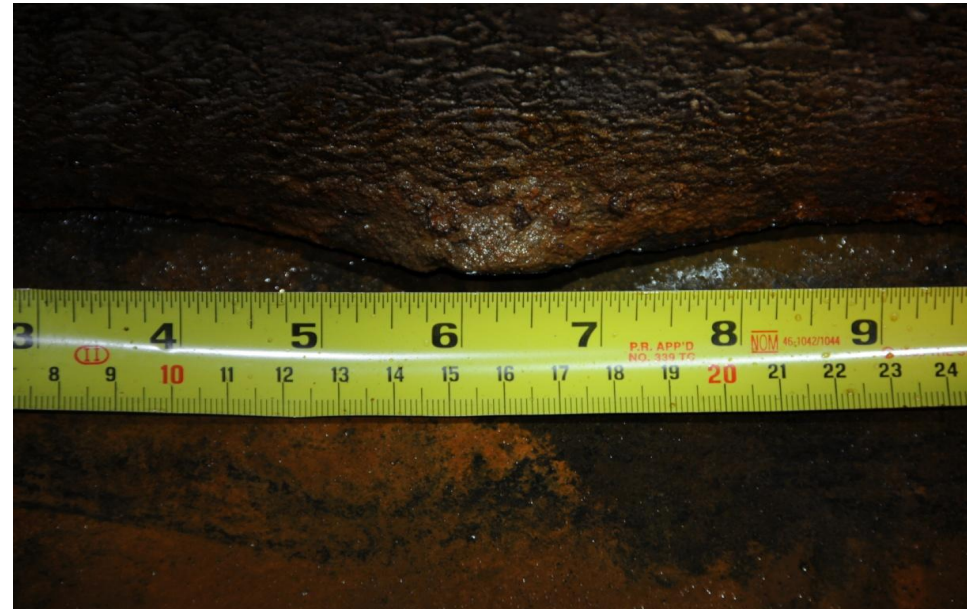
- The CSB observed visible metallurgical failures on the bottom interior surface of the tank that leaked into the Elk River.
- Holes and pits on the tank floor are a likely source of the MCHM leak.

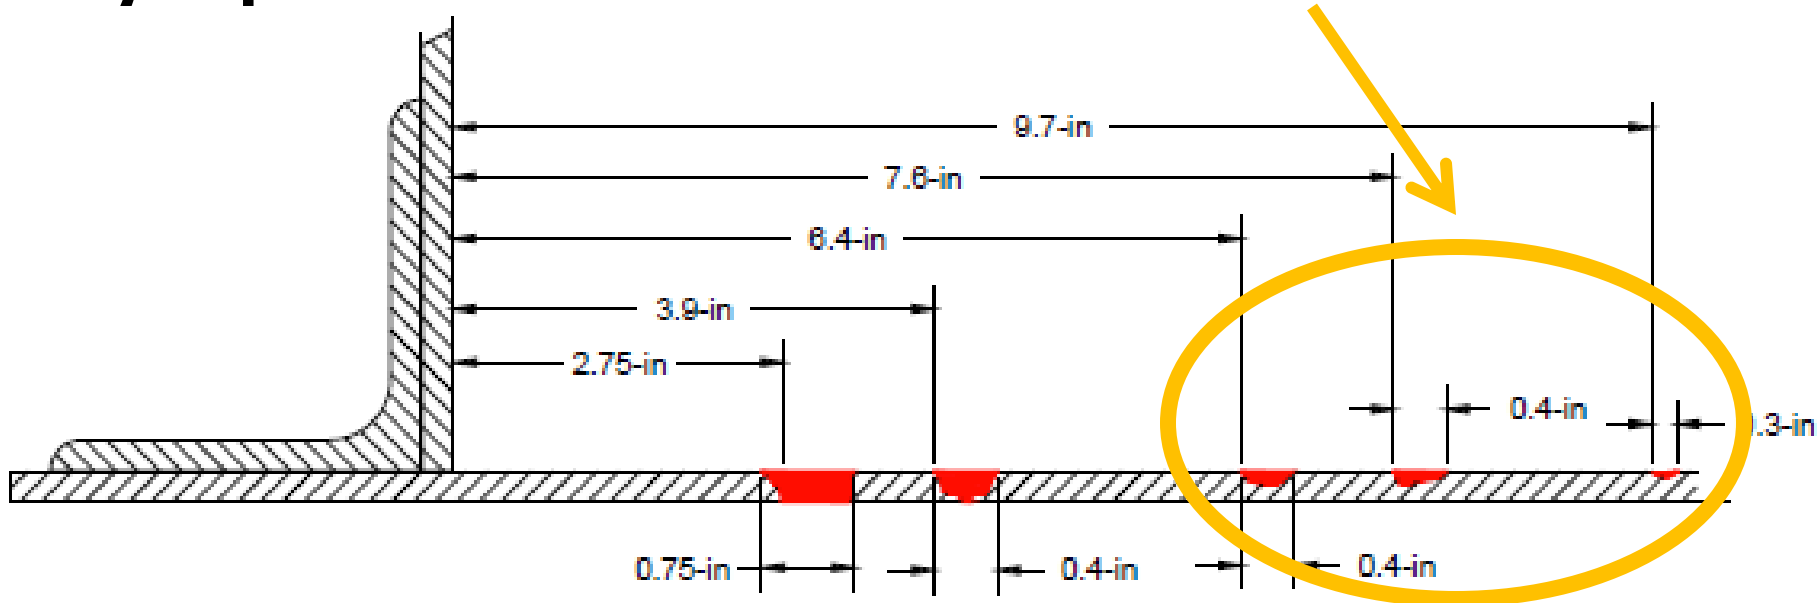
- The holes likely initiated from the interior of the tank due to corrosion associated with water pooling.
- Pitting observed from tank interior had not yet penetrated the bottom in other areas.

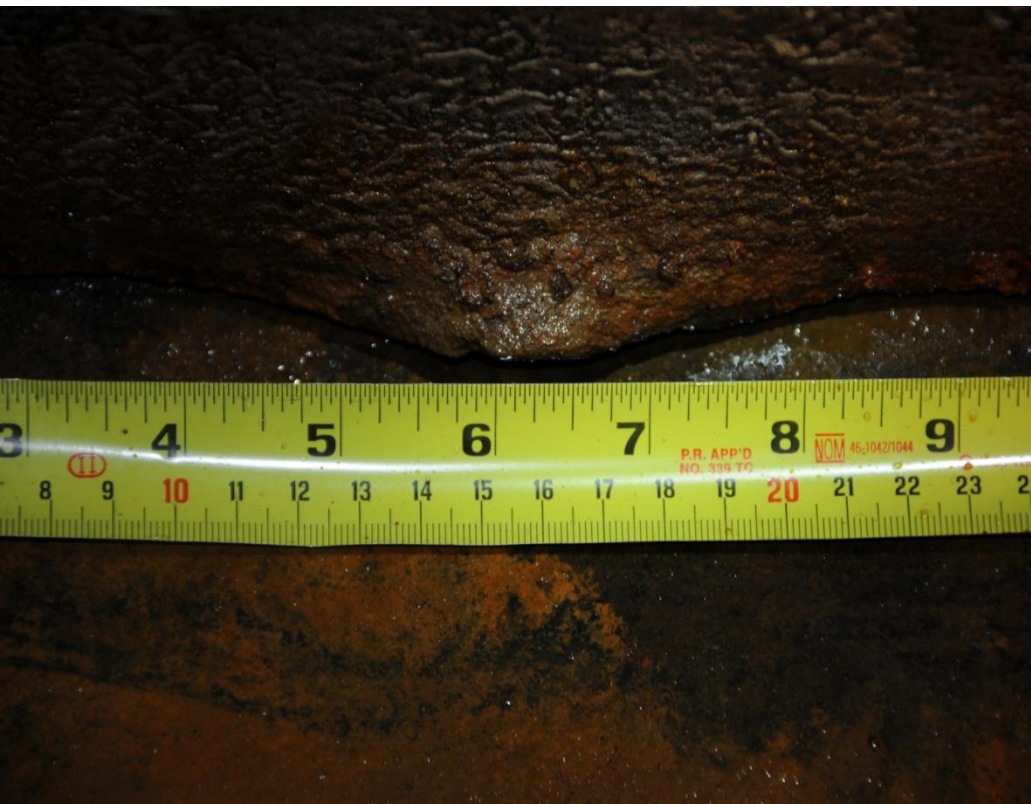
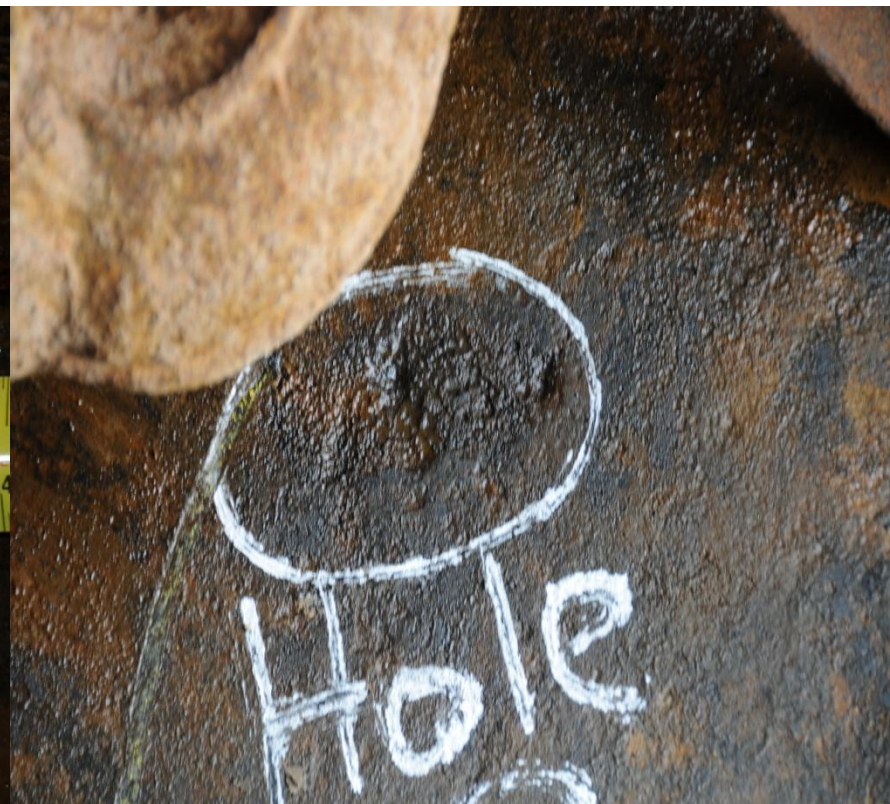
- Multiple pitting and metallurgical damage in T-396 and other tanks containing MCHM.

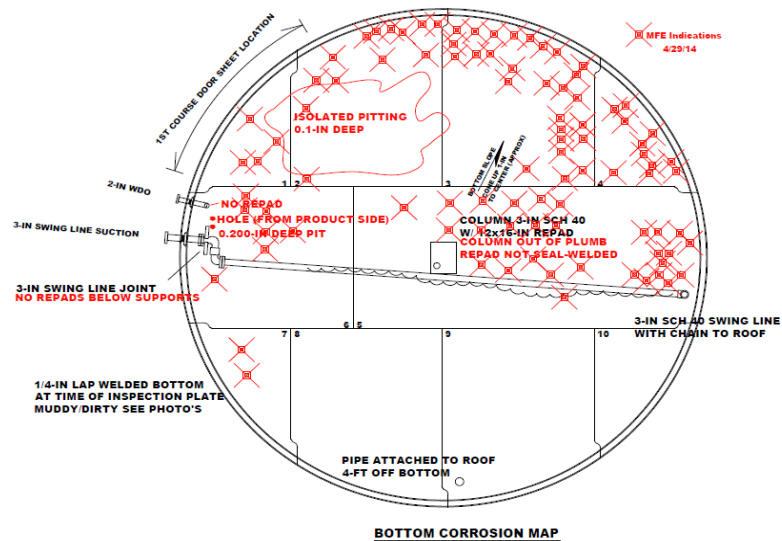
T-397

- Tank 397, another tank also containing the MCHM and PPH mixture, had a hole penetrating the bottom of the tank similar to the holes identified in Tank 396, the tank involved in the release.
- Due to extensive corrosion the CSB suspects that the leaks existed prior to January 9th
