Shattered windscreen of toughened safety glass

ETUI Seminar: Machinery Safety in Agriculture

Brussels, 5 March 2013

Subject: Combine accident of 11 August 2011

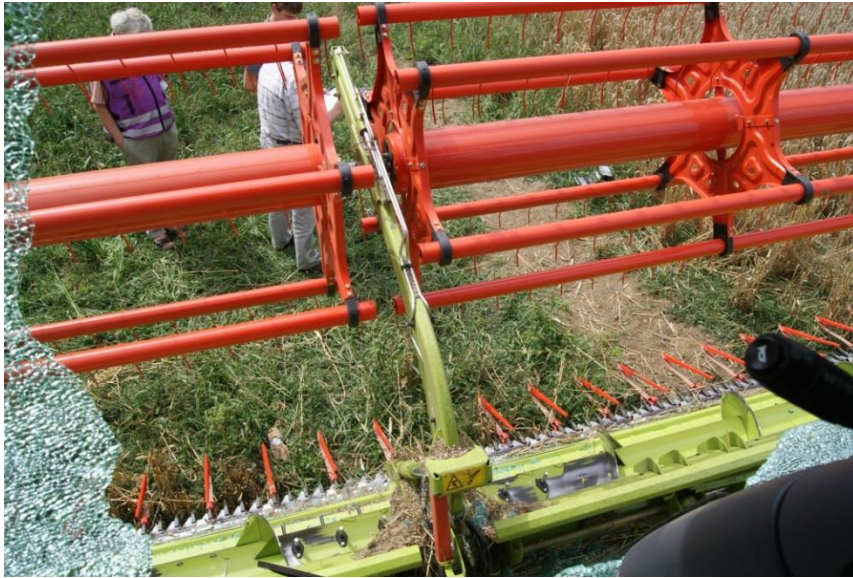
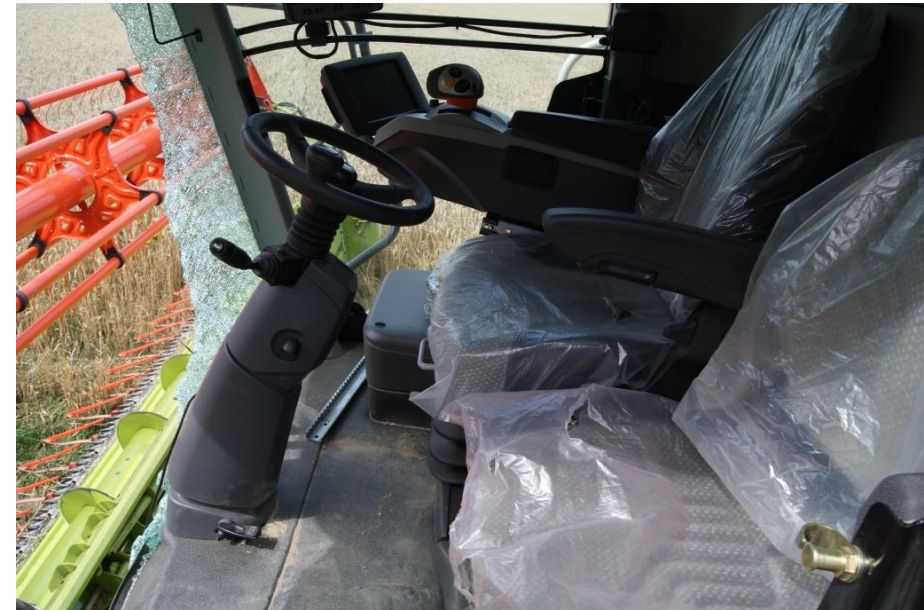
- Due to unknown reasons, the windscreen of a combine is shattered during the traversing movement. The trainee and the 5-year-old son of the driver were also in the cab and observed the harvesting process.
- Suddenly there was a loud bang and the windscreen of the cab was completely shattered. The driver stopped the combine with the hydrostatic drive immediately.
- Because of the colossal break force of the combine with hydrostatic drive on tracks the son of the driver was thrown through the front opening on the cutting table and trapped by the cross auger

- ❑ **Result:**
- ❑ The technical assessment of the used combine showed no evidence of a technical malfunction, a defect respectively an error in material or workmanship.
- ❑ Shattering of the windscreen by a collision of an occupant, the operation of the windscreen wiper or the retrieved feeder house slat can be largely eliminated.
- ❑ A glass beverage bottle lying on the bottom of the cab is able to shatter the toughened glass of the windscreen when it hits the windscreen because of a full breaking.
- ❑ A spontaneous rupture of the toughened glass is technically not excluded
- ❑ The problem of the present vehicle is that in case of rupture of the windscreen there is **no** further fall protection.
