Key Lessons for Preventing Hydraulic Shock in Industrial Refrigeration Systems

Anhydrous Ammonia Release at Millard Refrigerated Services, Inc.

January 2015

No. 2010-13-A-AL

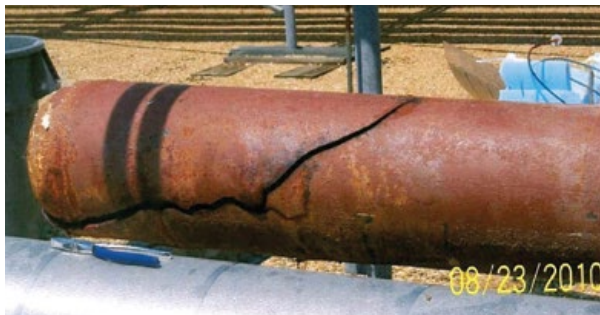
FIGURE 1

On August 23, 2010, at the Millard Refrigerated Services facility in Theodore, Alabama, hydraulic shock caused a roof-mounted 12-inch suction pipe to catastrophically fail leading to the release of more than 32,000 pounds of anhydrous ammonia. The hydraulic shock was enabled during the restart of the plant's ammonia refrigeration system following a 7-hour power outage. In addition to the catastrophic failure of roof-mounted piping, the pressure developed by the hydraulic shock event also caused an evaporator coil inside the facility to rupture.

Shortly before 9:00 am on the morning of August 23, 2010, Millard was in the process of loading two international ships with frozen poultry when the facility's refrigeration system experienced a hydraulic shock event that led to a catastrophic piping system failure and the release of 32,100 pounds of anhydrous ammonia. The majority of the ammonia released in this incident occurred through a compromised portion of the system's 12-inch suction pipe located on the roof (Figure 1). The resulting cloud of ammonia vapor traveled 0.25 miles to the south across the Theodore Industrial Canal, exposing a Millard employee and offsite contractors working outdoors.⁴ At approximately the same time, alarms sounded within the plant due to the detection of high concentrations of ammonia indoors by air-monitoring equipment in the freezers. The ammonia detected within the facility was the result of a second leak that developed because a portion of the system's blast freezer⁵ evaporator header ruptured (Figure 2).

Ruptured 12-inch diameter end cap of low-temperature suction line piping on the roof of Millard facility (OSHA).

1. For the design of ammonia refrigeration systems, avoid grouping multiple evaporators to a single set of control valves. This is especially important for large capacity evaporators in excess of 20 tons. Evaporators with hot gas defrost systems should be controlled by individual valve control groups dedicated to each evaporator coil.

2. Program or configure defrost control systems with interlocks to ensure the low-temperature liquid feed and hot gas remain isolated during the initiation and termination of the hot gas defrost cycle in the event of a power outage, cycle interruption, or other abnormal situation. Program the defrost control sequence to automatically depressurize or bleed the coils in defrost upon restart after an outage or interruption, prior to opening the suction stop valve to set the evaporator into cooling mode.

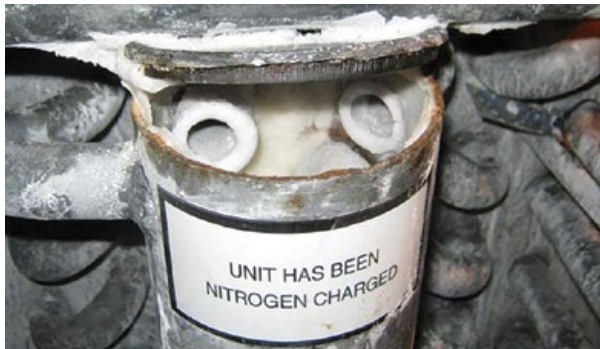
FIGURE 2

Freezer 5 evaporator coil weld failure after the incident (OSHA).
