# Assessment of the arm locking systems of two-post vehicle lifts

Prepared by the **Health and Safety Laboratory**  
for the Health and Safety Executive 2015

Following a number of instances of vehicles falling from two-post vehicle lifts, the Health and Safety Executive (HSE) became concerned that some lifts available for sale in the United Kingdom (UK) may not be fit for purpose due to inferior build quality and or design. A particular area of concern identified by HSE was the locking systems used to secure the carrying arms during lifting operations.

The purpose of this research was to investigate whether a selection of typical two-post vehicle lifts forming a cross-section of what was available on the UK market (at the time the research was instigated), complied with the requirements of paragraph four of section 5.9.5 in BS EN 1493:2010.

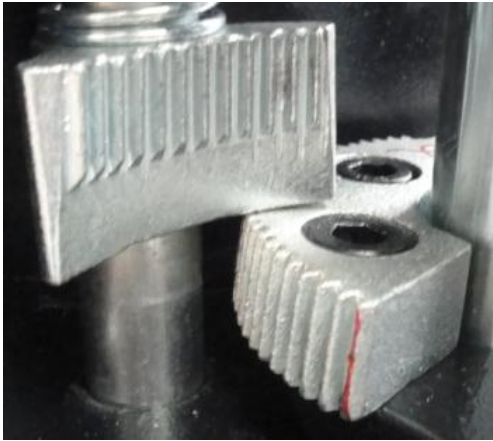
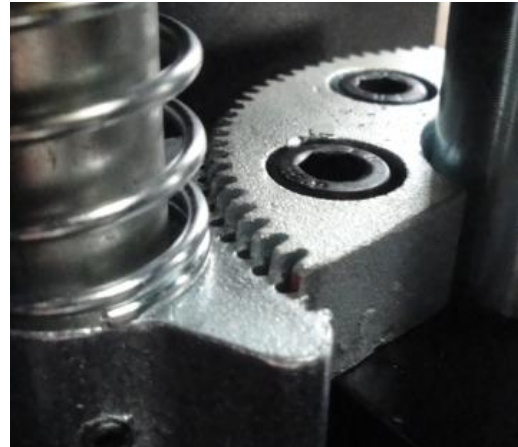
**Figure 8:** Pre test-1 condition of the carrying arm locking gears (VL-1)

As can be seen in Figure 8, after installing the carrying arm there was a noticeable stand-off of 3-5mm between the locking block and carrying arm gear.

Image (cropped): DSC02098 – poor engagement

- **Inspecting for stand-off present between the locking block and arm gear:** a stand-off between the locking block and arm gear was observed on four out of the seven vehicle lifts tested. Removing the stand-off would increase the amount of surface area engaged, potentially increasing the locking systems ability to resist the applied load.

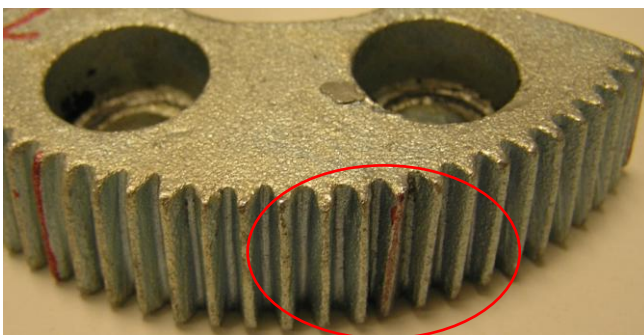
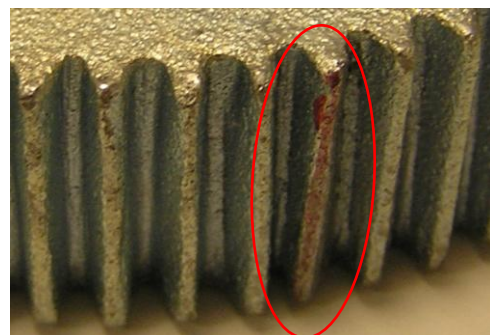
**Figure 9:** Post test-1 condition of the carrying arm gear (VL-1)

Figures 9 and 10 show the post-test condition of the gears. As can be seen, VL-1 failed to meet the requirements of the standard. On the 4.5% test there was permanent deformation visible on both the carrying arm gear (area circled in Figure 9 highlights where one of the gear teeth has plastically deformed) and locking block with the area circled in Figure 10 highlighting the indentations witnessed on the top land and tooth flank of some of the locking block gear teeth.

Image (cropped): P1010192 – arm gear

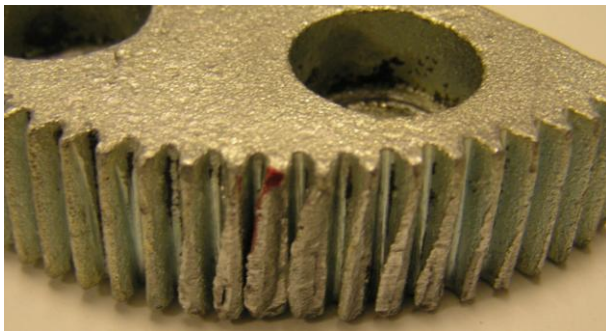
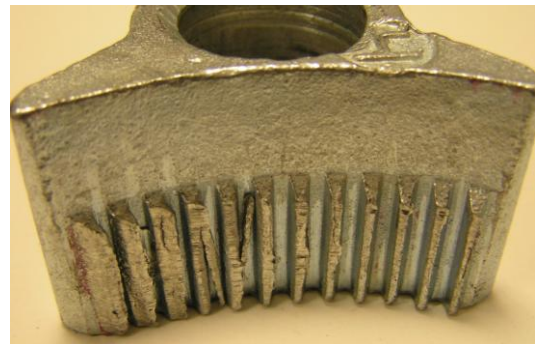
**Figure 11:** Post test-2 condition of the gears (VL-1)

During test-2 only 50-75% of the teeth were partially engaged and carrying the applied load. The other 25-50% of the teeth had completely disengaged when the applied load was increased. This meant that the arm locking system failed at an applied load of 150Kgf, which is lower than that applied during test-1 (180Kgf). This is due to the gears having less engagement for test-2 to that which was obtained during test-1. The gear teeth that had the greater levels of engagement, ultimately suffered the greatest level of deformation (see Figure 11).

Vehicle lifts VL-1 and VL-2 were manufactured by the same company (with identical casting marks seen on both sets of gears), but have been branded and sold separately. The overloading and subsequent failure of the locking system on both lifts could possibly be attributed to rotational disengagement of the locking gears. When a load is applied to the end of the carrying arm, the locking block resisting the applied load will want to rotate in the opposite direction to that which the load is being applied. A sufficient amount of excess backlash present in the locking system would enable the locking block to rotate enough that the rear locking block teeth become disengaged from the arm gear. The load being applied is therefore transferred to the leading locking block teeth that dig in and act as a pivot point.

Increasing the amount of backlash present in the locking system, will lead to greater levels of rotational disengagement, and an increased risk of failure due to overloading.

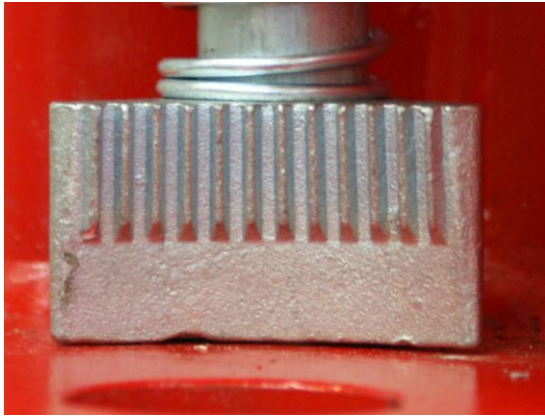
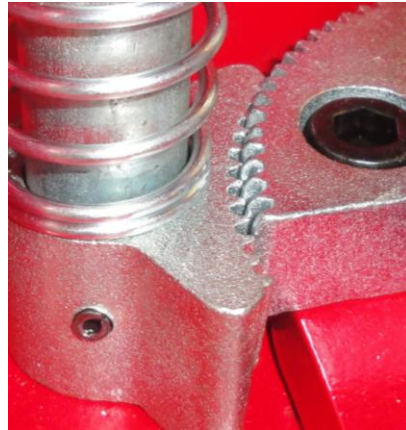
**Figure 12:** Showing the engagement of the locking gear (VL-2) before test-1

As can be seen in Figure 12, the quality and construction of the locking gear system is identical to that of VL-1, with a similar stand-off witnessed between the locking block and carrying arm gears tested (3-5mm). There was also a similar amount of end float in the carrying arm to that of VL-1.

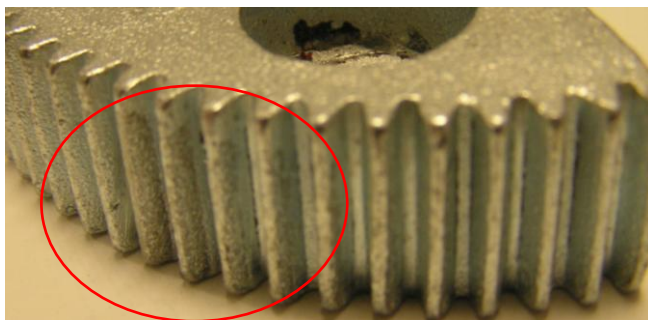
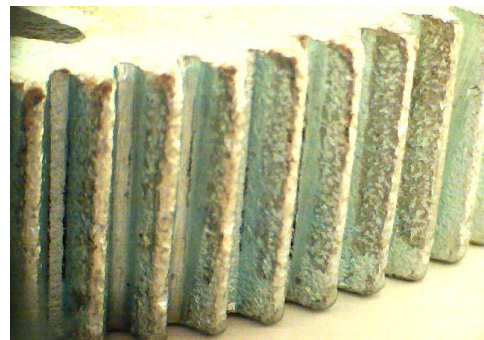
**Figure 13:** Post test-1 condition of the carrying arm gear (VL-2)

On the 4.5% test there was permanent deformation visible on both the carrying arm gear and locking block. This came in the form of burnishing on the arm gear tooth flank (seen as surface discolouration in Figure 13), and indentations on the top of the locking block tooth flank, seen in Figure 14.

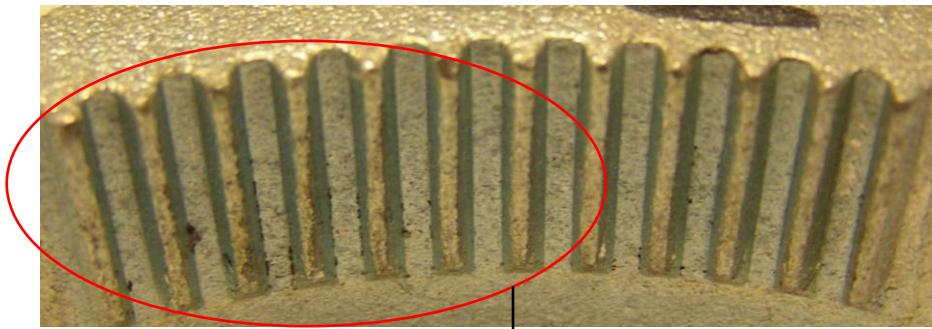
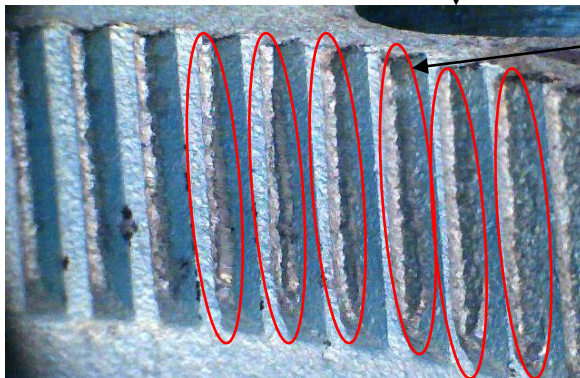
**Figure 14:** Post test-1 condition of the locking block (VL-2)

Indentation and surface burnishing visible at the top of each gear tooth.

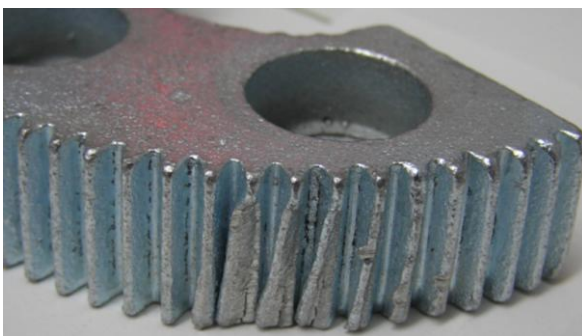
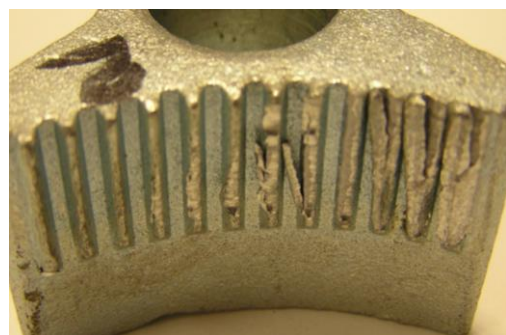
**Figure 15:** Post test-2 condition of the gears (VL-2)

On the 6.75% test, the locking system failed before reaching the prescribed loading of 270Kgf (see Figure 15) and failed at a lower load to that applied during test-1 (180Kgf). Similarly to VL-1, this is due to the locking system achieving a lower standard of engagement to that which was obtained during test-1.

As can be seen in Figure 15 the teeth have completely deformed, and in some instances sheared through the middle of the tooth flank.

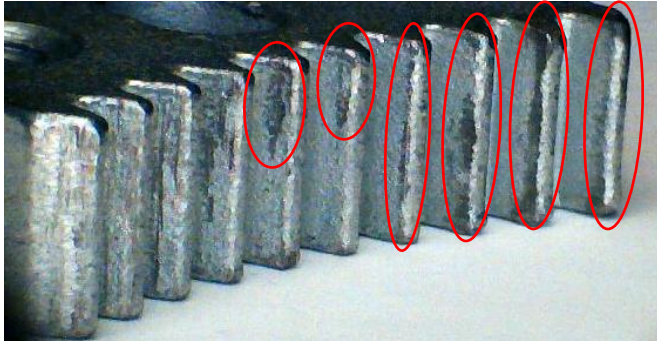
**Figure 17:** Post test-1 condition of the locking block (VL-3)

Figures 17 and 18 show the condition of the gears after the 4.5% load test. As can be seen there is permanent deformation in the form of surface burnishing on the locking block (see the areas circled in red on figure 17). On the carrying arm gear, indentions are visible on the flanks of the gear teeth (see the areas circled in red on figure 18).

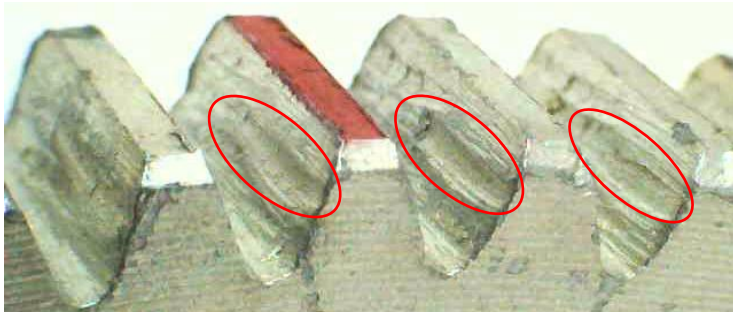
**Figure 18:** Post test-1 condition of the carrying arm gear (VL-3)

Image (cropped) Picture 017: Macro image showing indentations in the arm gear tooth flank

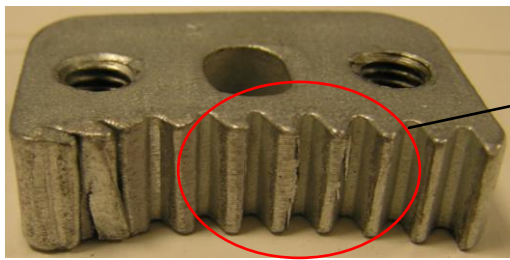
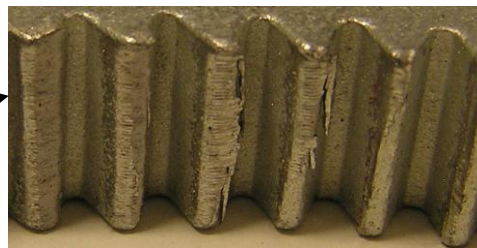
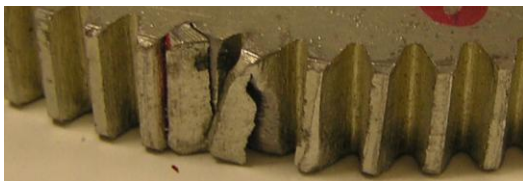
**Figure 19:** Post test-2 condition of the gears (VL-3)

Figure 19 shows the condition of the gears after the 6.75% load test. As can be seen, there has been a complete failure of the locking system with some of the teeth in both the locking block and carrying arm gear being completely deformed, with fractures at the root of some, and mechanical deformation across the tips of others.

When VL-3 was tested it failed to meet the requirements of the standard. This could be due to the smaller gear tooth profile and therefore lack of required surface area to carry the prescribed load (leading to overloading of the gear teeth).

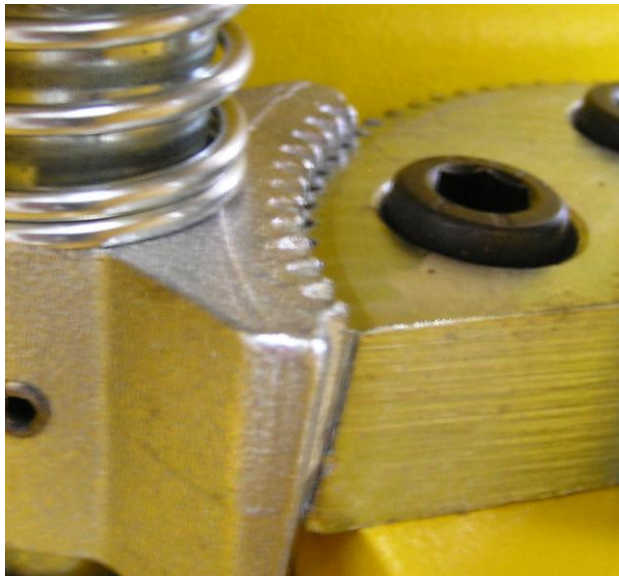
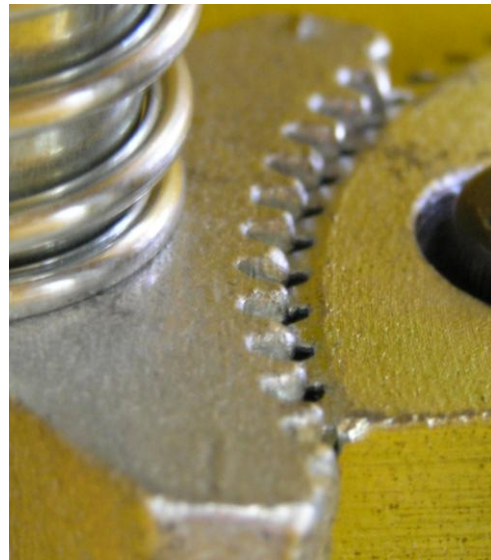
**Figure 20:** Engagement of the locking gears (VL-4) prior to test-1

Figure 20 shows the gear engagement achieved during the testing of VL-4. There was little to no adjustment of the gears available in the locking system, and a slight stand-off of 2mm was witnessed between the gears. The quality of engagement can be attributed to the severity of the carrying arm gear taper, which was not matched on the locking block. A soft faced hammer was used to lightly tap the top of the locking block pin and aid the engagement. There was little to no rotation in the carrying arm once correctly positioned and locked.

VL-4 had what looked like a well manufactured arm gear (with a pronounced tapered profile). However, this was used in conjunction with a locking block which lacked the same profile, and therefore did not fully engage. As there was limited adjustment available, this meant that the locking system had a slight stand-off. However, it was observed that VL-4 had minimal end float of the carry arms when positioned and locked. Although VL-4 failed the 4.5% load test, it passed the 6.75% test, and therefore met the requirements of BS EN 1493:2010<sup>1</sup>.

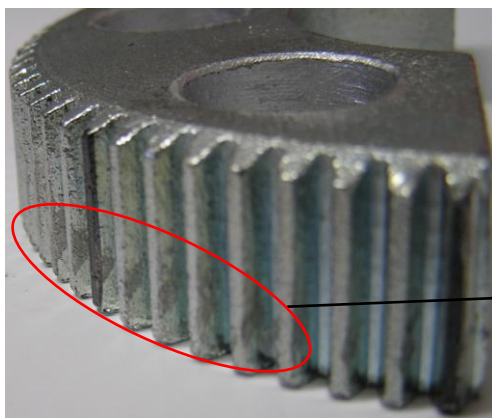
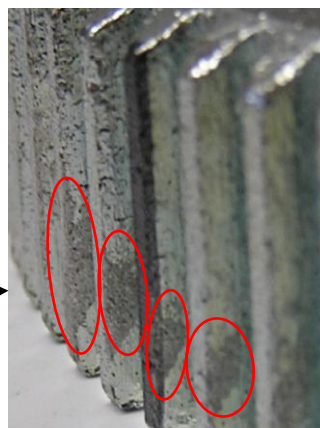
**Figure 21:** Post test-1 condition of the arm gear (VL-4)

The post-test inspection showed evidence of permanent deformation in the form of surface burnishing on the arm gear (see Figure 21) and locking block (see Figure 22).

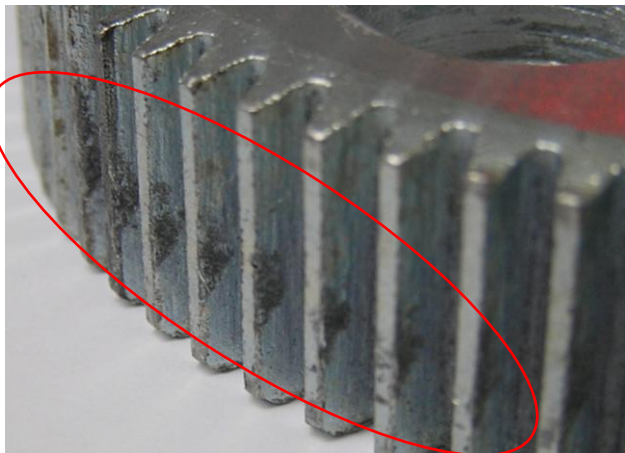
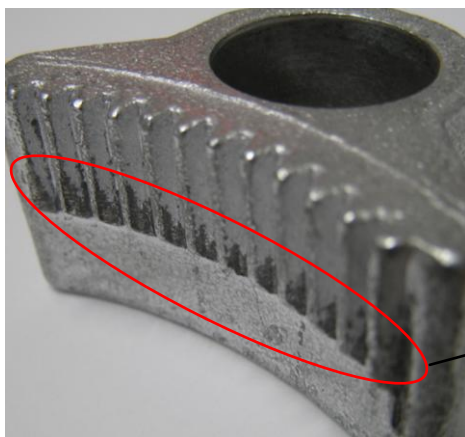
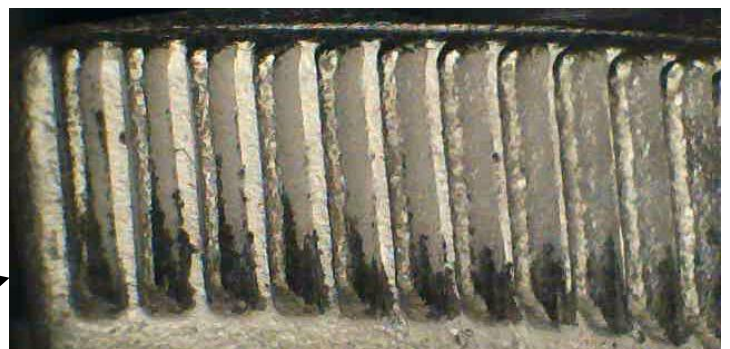
**Figure 23:** Post test-2 condition of the gears (VL-4)

On the 6.75% test, there was an increase in the amount of permanent deformation visible on the carrying arm gear and locking block (see Figure 23). However, as the locking system did not fail at an applied load of 229Kgf, it was deemed to have satisfied the requirements of BS EN 1493:2010<sup>1</sup>.

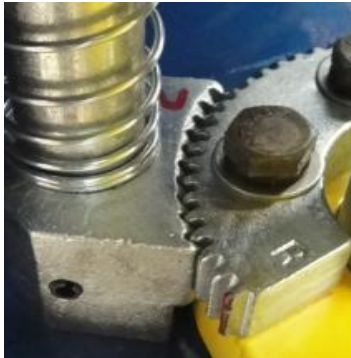
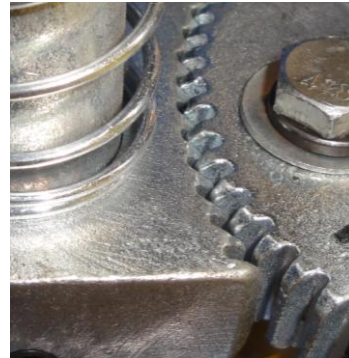
**Figure 24:** showing the quality of locking gear engagement (VL-5) before test-1

In Figure 24 the locking gear engagement achieved during the testing of VL-5 can be seen. After positioning the carrying arm for testing, there was still a small amount of rotation available in the carrying arm, as well as a slight stand-off of 1-2mm between the arm gear and locking block.

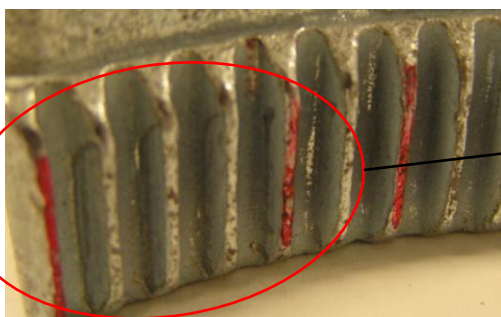
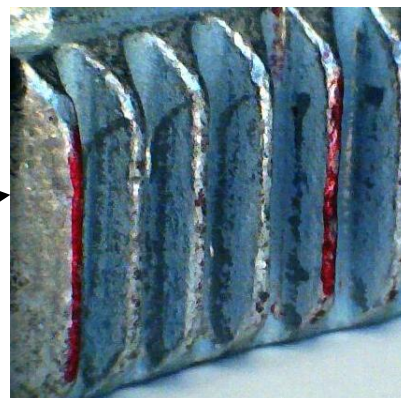
**Figure 25:** Post test-1 (8.8 grade bolts) condition of the locking block (VL-5)

During the first test, two out of the three bolts holding the arm gear to the carrying arm sheared (at 138Kgf applied load) prior to reaching the specified load. The test was repeated using another set of bolts supplied with the vehicle lift, to see whether the bolts shearing were an anomaly or, were an indication that the bolts supplied did not have a high enough rating for the prescribed load. Once again the bolts failed (middle bolt sheared) before reaching the specified load.

As the bolts are an integral part of the locking system, the repeated shearing of the bolts securing the carrying arm gear can be classed as a failure to meet the requirements of BS EN 1493:2010<sup>1</sup>. However, so the functionality of the locking system gears could be tested, the bolts supplied with the vehicle lift were exchanged for more appropriately rated 8.8 grade bolts that had been supplied by HSL – Engineering Support. With these bolts in place, the locking system failed to pass the 4.5% load test as there was permanent deformation in the form of burnishing along the bottom land of the locking block and arm gear (see Figures 25 and 26).

VL-5 had little to no adjustment available in the locking gears to remove any of the backlash experienced. After conducting the testing, the failure of the locking system was not due to the construction of the gears used (as has been demonstrated in the results - Section 6.1.5), but the bolts that had been supplied with the vehicle lift to secure the arm gear to the carrying arm.

However, one improvement that has been tested, and can be recommended with a degree of certainty, is to improve the grade of bolts used to secure the arm gear to the carrying arm on VL-5. This improvement was tested (see section 6.1.5), and enabled VL-5 to pass the requirements of BS EN 1493:2010<sup>1</sup>.

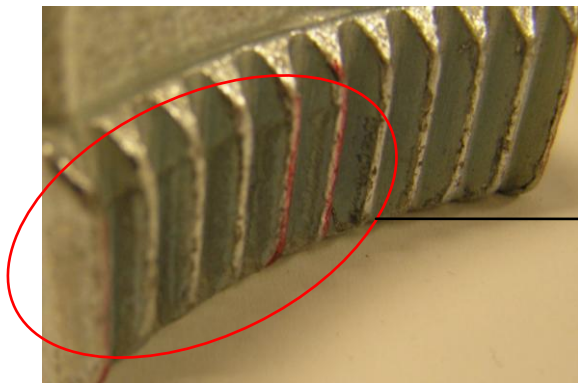
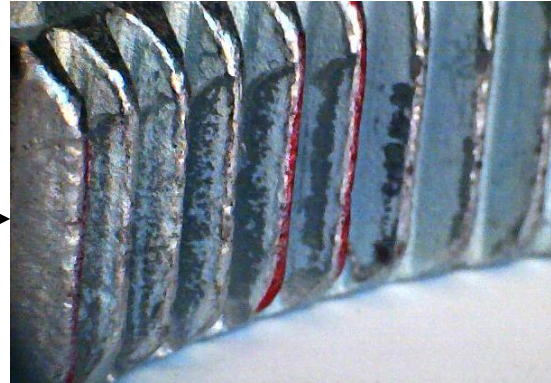
**Figure 27:** Post test-2 (8.8 grade bolts) condition of the locking block (VL-5)

Like VL-4, the locking system was able to pass the 6.75% load requirements (using 8.8 grade bolts supplied by HSL – Engineering Support), although there was an increase in the amount of indentations and surface burnishing (seen as discolouration to the tooth flank) visible on both the locking block and carrying arm gear teeth (see Figures 27 and 28).

The bolts used to attach the arm gear, were exchanged for improved bolts supplied by HSL – Engineering Support. Although VL-5 still failed to pass the 4.5% load requirement due to visible deformation on the tooth flank, it did manage to meet the 6.75% load requirement, and therefore pass the requirements of BS EN 1493:2010<sup>1</sup>.

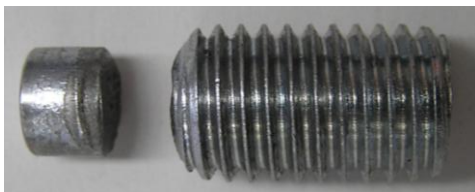
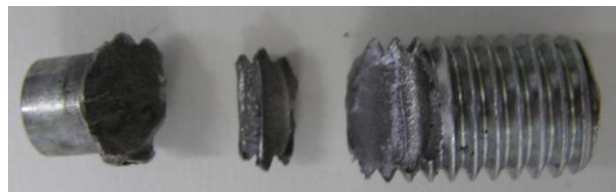
**Figure 30:** Sheared securing dowels (VL-6)

VL-6 managed to pass the 4.5% load test with no visible damage to any of the gear teeth, and therefore met the requirements of the standard. During test-2, the metal dowels securing the carrying arm to the pin, failed at an applied load of 180Kgf (6.75% load test). As the engagement of the locking gears was good, the moment being applied was transferred straight to the securing dowels, which sheared (see Figure 30).

- The arm gear attachment bolts supplied by the manufacturer of VL-5, were unsuitable for meeting the loading requirements of the standard.
- The dowels used to secure the locking system of VL-6 to the carrying arm, failed during the 6.75% load test.

for the operator to be able to see whether the carrying arm is correctly secured prior to operating the lift. VL-6 met the requirements of the 4.5% test but failed to meet the requirements of the 6.75% SWL test due to sheared retaining dowels. VL-7 used the same dowels to secure the locking system into the carrying arm as those used by VL-6. However, VL-7 was able to pass both the 4.5% and 6.75% SWL tests as the locking system uses three securing dowels as oppose to the two seen on VL-6.

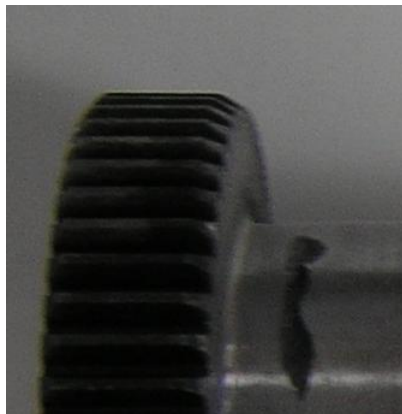
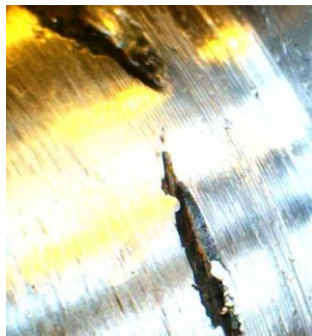
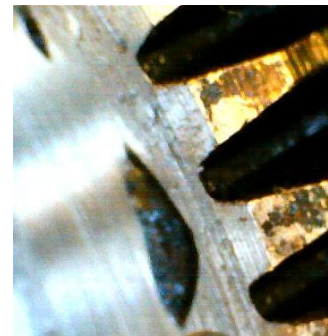
**Figure 32:** Notches in the pin and spur gear (VL-7)

Upon examination of the gears prior to conducting the test, and although most likely inconsequential to the quality of the locking system as a whole, it was noted that there were notches in the securing pin, as well as in the spur gear (see Figure 32). These were most likely due to voids that had formed below the surface during the casting process, and had been exposed during subsequent machining.
