FINAL INVESTIGATION REPORT

CHEVRON RICHMOND REFINERY PIPE RUPTURE AND FIRE

CHEVRON RICHMOND REFINERY #4 CRUDE UNIT RICHMOND, CALIFORNIA

REPORT NO. 2012-03-I-CA
JANUARY 2015

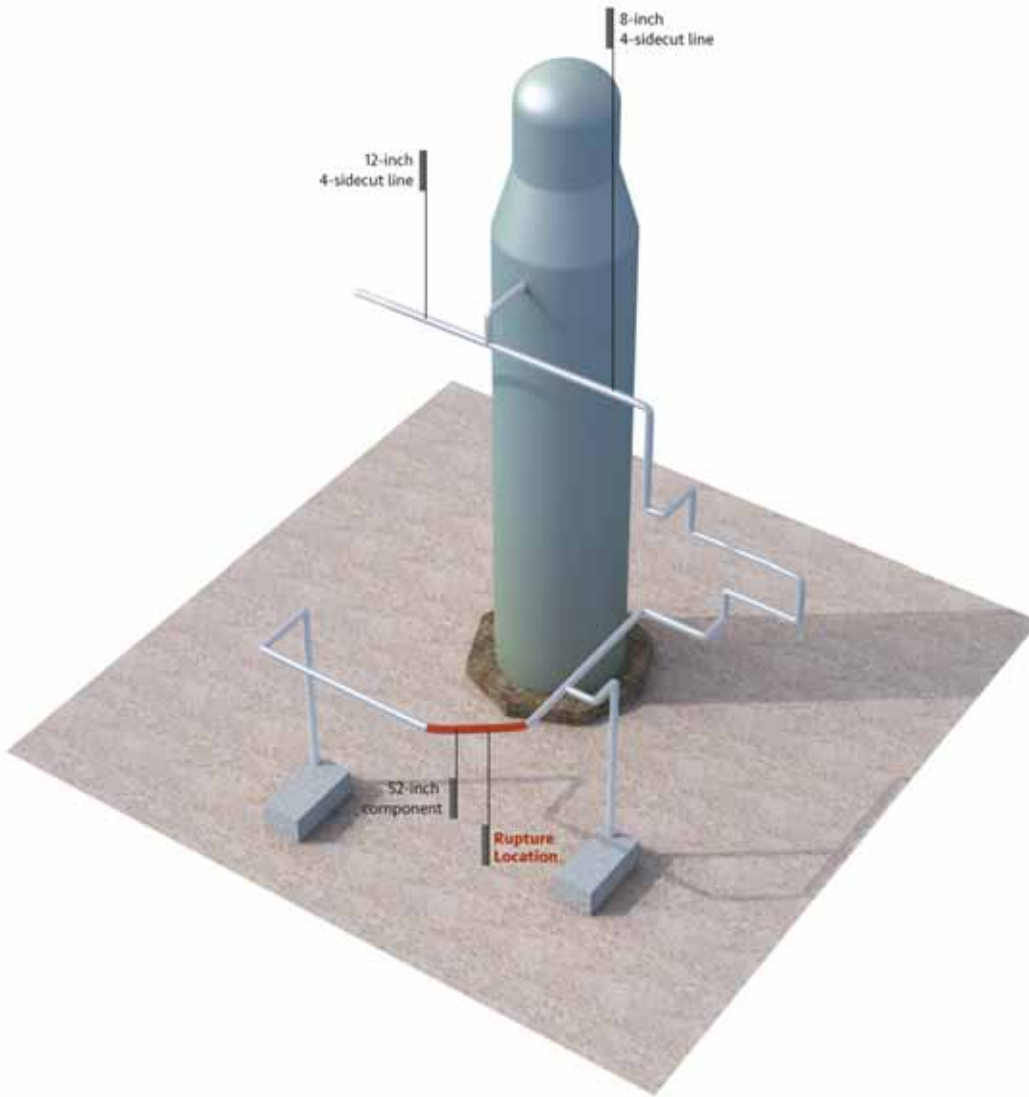
Figure 4. 4-sidecut line configuration and rupture location.

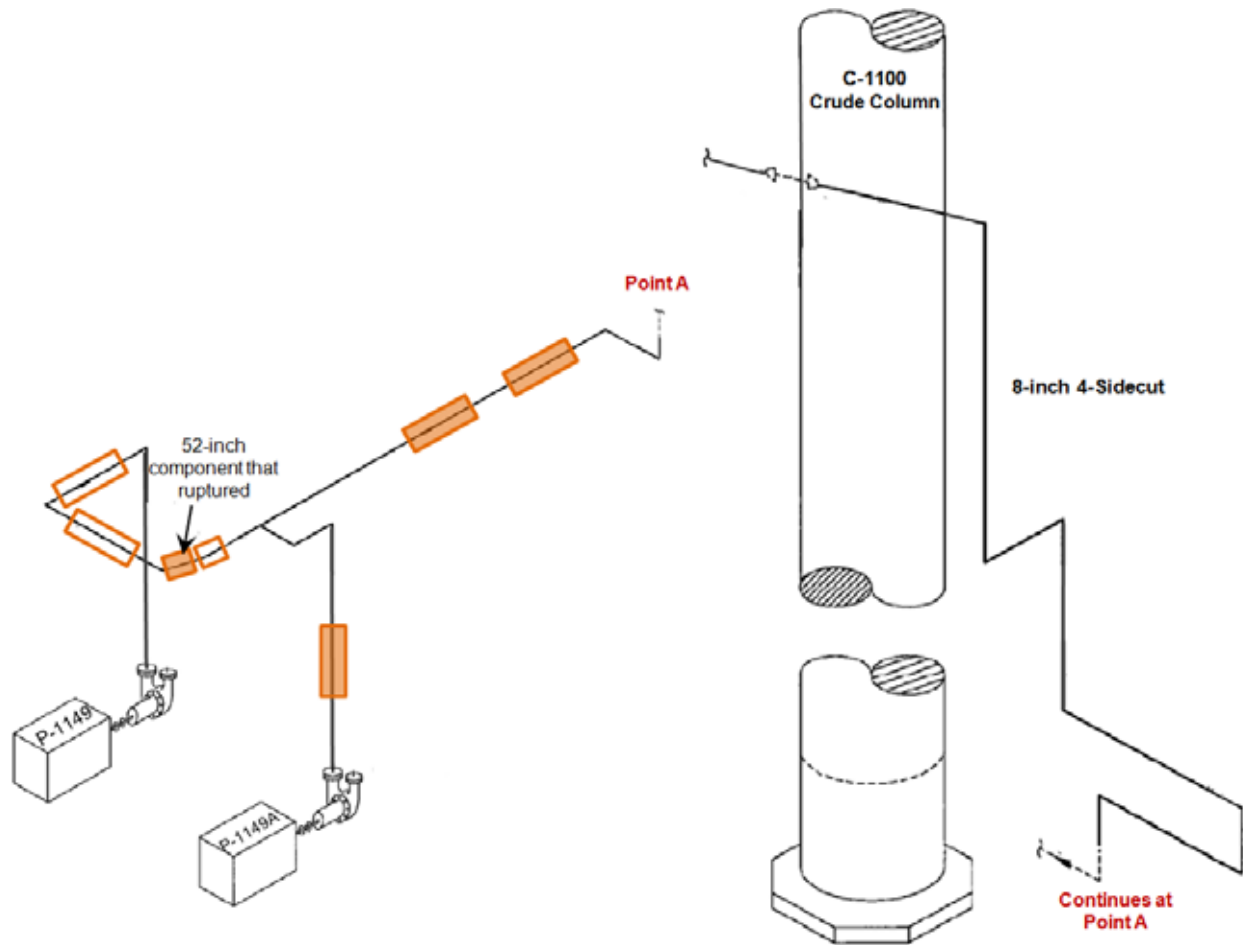
Figure 18. Locations of metallurgical samples taken from 8-inch 4-sidecut piping post-incident. The seven samples taken are boxed in orange. Four of the seven components sampled (shown with an orange fill) were found to have a silicon content less than 0.10 weight percent.

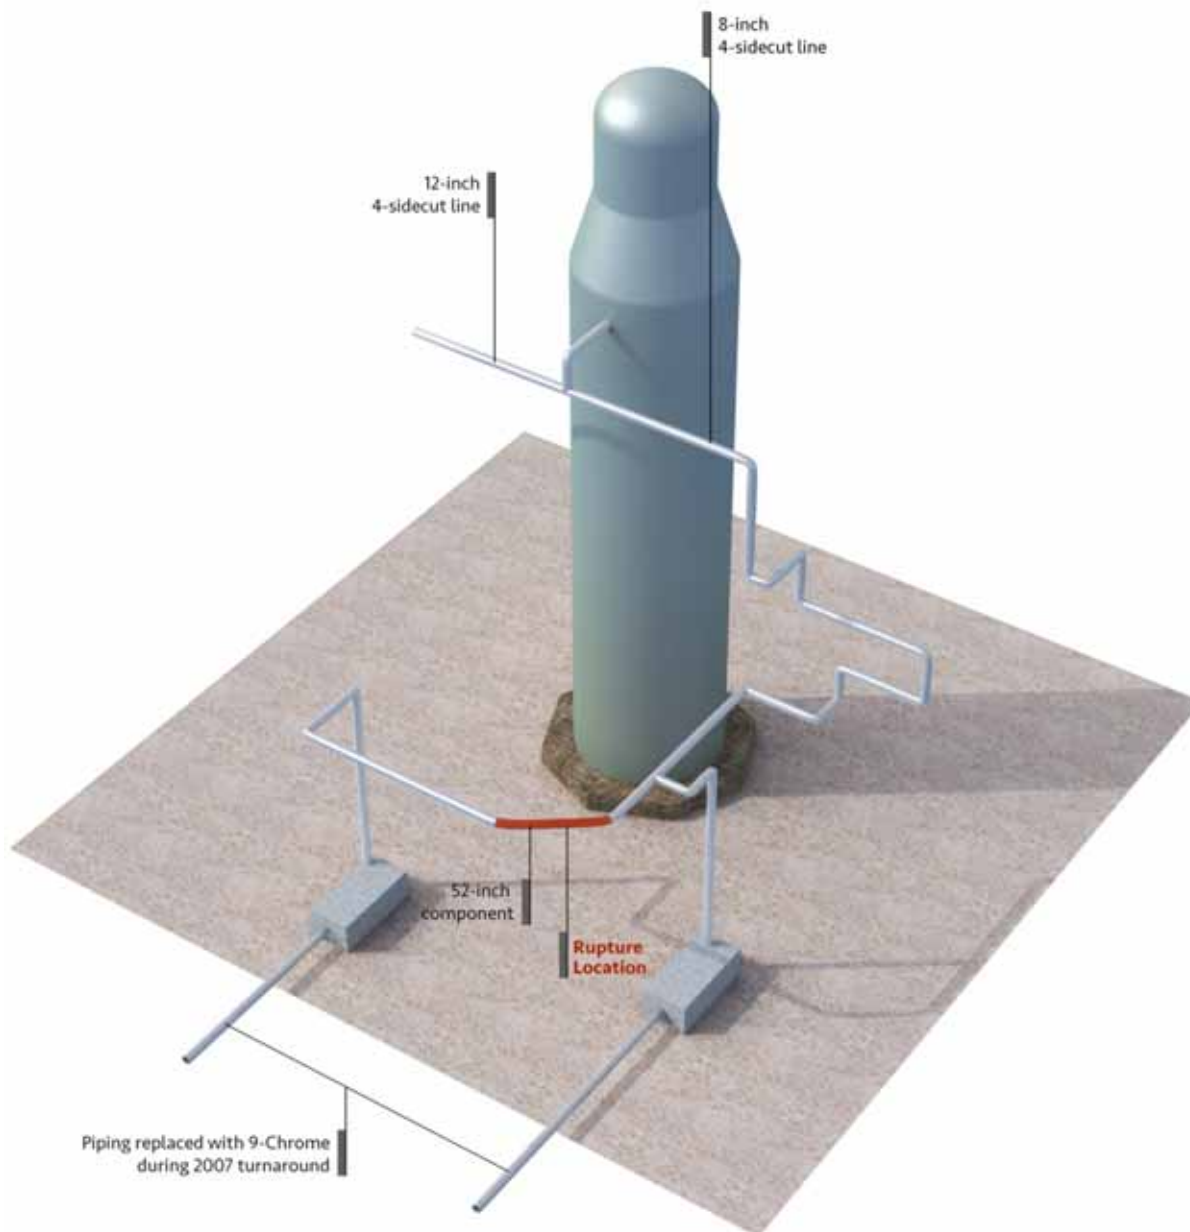
Figure 33. Crude column schematic indicating the piping downstream of the 4-sidecut pumps that was replaced during the 2007 Crude Unit turnaround. The portion of the carbon steel line containing the component that failed on August 6, 2012 was not replaced.

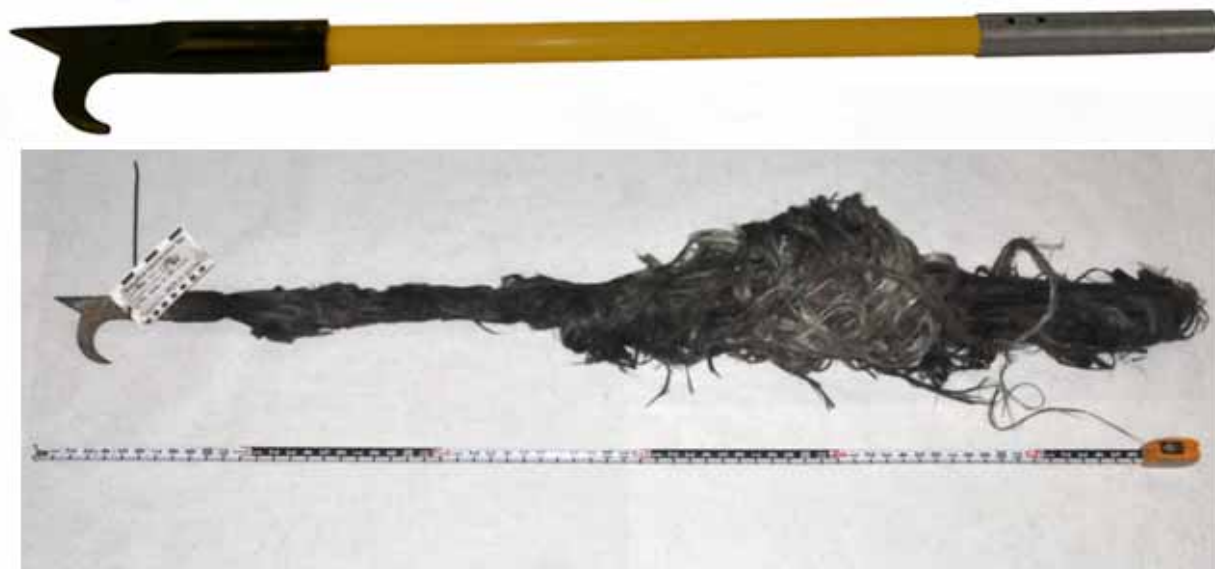
Figure 40. Photo of undamaged¹⁷⁹ (top) and burned during incident (bottom) pike pole used in early attempts to remove 4-sidecut insulation.
