Key Lessons for Preventing Hydraulic Shock in Industrial Refrigeration Systems

Anhydrous Ammonia Release at Millard Refrigerated Services, Inc.

January 2015

No. 2010-13-A-AL

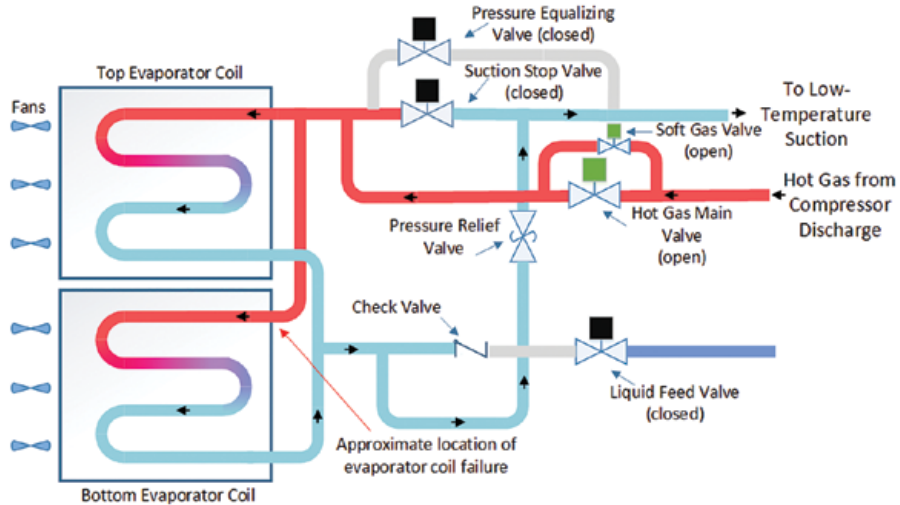
FIGURE 5

Simplified flow diagram of hot gas defrost

Another contributing factor in this incident was the design and configuration of the blast freezer evaporators at the Millard facility—specifically, connecting multiple evaporator units onto a single control valve group. This design approach allowed for an excessively large volume of high-pressure gas to be introduced to the suction line when the suction stop valve was prematurely opened. Millard and the designers of the refrigeration system designed the blast freezer evaporators at the Theodore facility with four evaporator coils grouped to one set of control valves. With this design, one set of valves controlled the liquid feed, hot gas, and suction for all four evaporator coils during cooling mode and the defrost cycle. The evaporator assembly at Millard consisted of a pair of evaporators with two coils each, stacked vertically. Liquid ammonia fed into the coils from the bottom of the coil and the hot gas fed the coils from the top (see Figure 5 for stacked evaporator configuration).

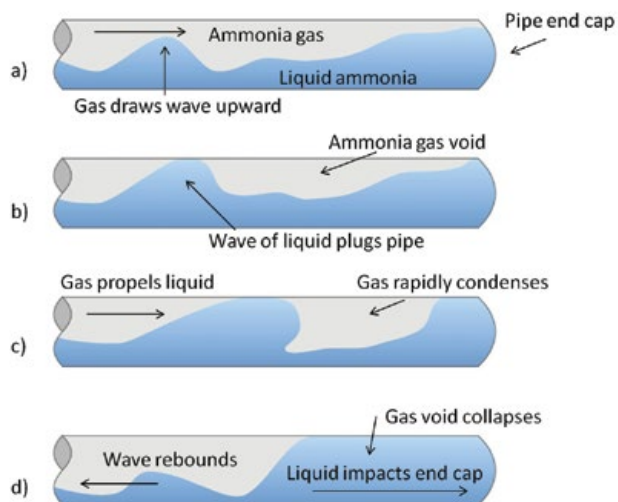
FIGURE 6

During hot gas defrost, the evaporator coils are isolated from the low-temperature suction line by closing the suction stop valve. The evaporator piping (upstream) of the suction stop valve is pressurized while the downstream low-temperature suction piping contains low pressure vapor and liquid returning from other evaporators in service. A cause of shocks more common in ammonia systems is the rapid opening of a valve from high pressure to low pressure.¹⁵ If the coil rapidly depressurizes, refrigerant liquid and vapor will accelerate through the suction stop valve and into the downstream suction piping. The gas will suddenly condense to a liquid, which can lead to condensation-induced shock when voids of trapped gas build up pressure and rapidly condense, creating a vacuum (Figure 6).¹⁶ The reduction in volume produces an inrush of fluid from other parts of the system. The liquid accelerates at a high velocity and when it arrives at an obstruction, such as an end cap, it abruptly stops and exerts a force on the piping. The exerted force stresses the pipe and joints and, in severe cases, results in component failure. The failure at Millard was likely caused by a combination of condensation induced shock and vapor-propelled liquid. These two mechanisms often work together during hydraulic shock events in ammonia refrigeration systems.

Progression of a condensation-induced shock event.
