# Assessment of the arm locking systems of two-post vehicle lifts

Prepared by the **Health and Safety Laboratory**  
for the Health and Safety Executive 2015

Following a number of instances of vehicles falling from two-post vehicle lifts, the Health and Safety Executive (HSE) became concerned that some lifts available for sale in the United Kingdom (UK) may not be fit for purpose due to inferior build quality and or design. A particular area of concern identified by HSE was the locking systems used to secure the carrying arms during lifting operations.

The purpose of this research was to investigate whether a selection of typical two-post vehicle lifts forming a cross-section of what was available on the UK market (at the time the research was instigated), complied with the requirements of paragraph four of section 5.9.5 in BS EN 1493:2010.

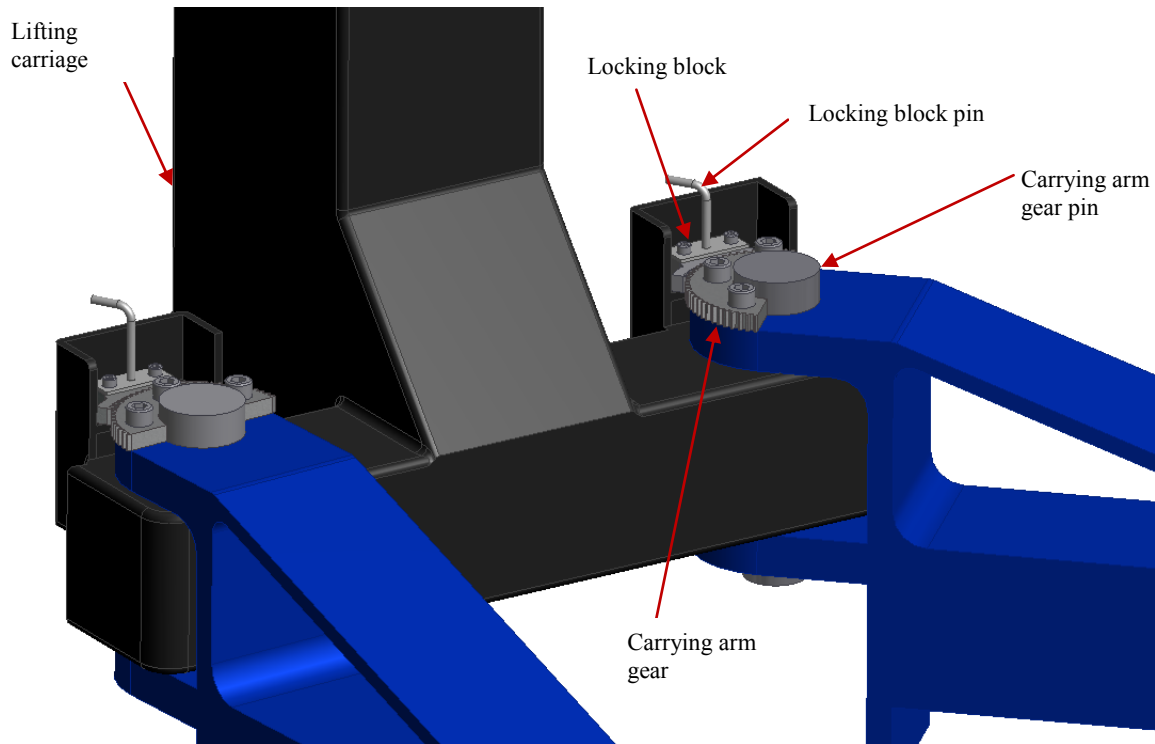
**Figure 16:** CAD image showing a carrying arm attachment method similar to that of VL-3

VL-3 used a slightly different design to that of the other lifts utilising the 180° locking system. Instead of having the locking block and carrying arm positioned within the lifting carriage, with the carrying arm securing pin going through; carriage – arm – carriage, the carrying arms on VL-3 fitted around the lifting carriage with the securing pin going through; arm – carriage – arm. This meant the locking block and arm gear was located on top of the lifting carriage (see Figure 16).

The carrying arm and locking block gears also had a smaller gear profile (less than half the size) when compared to that used by the other vehicle lift manufacturers. When positioning the carrying arm into the correct orientation for testing, there was little to no backlash in the gears.

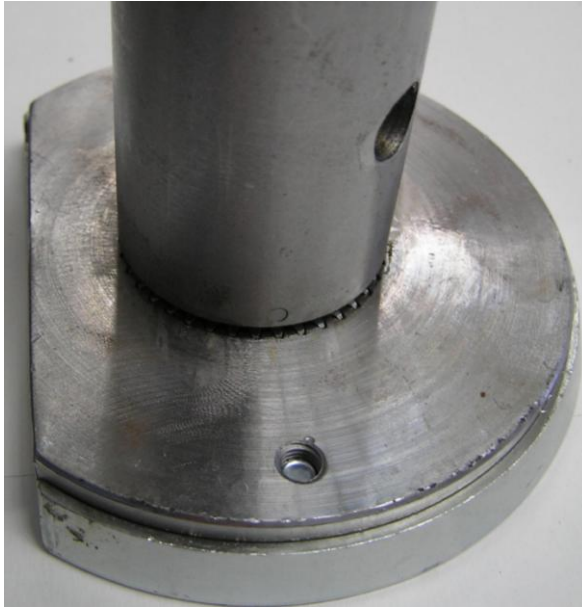
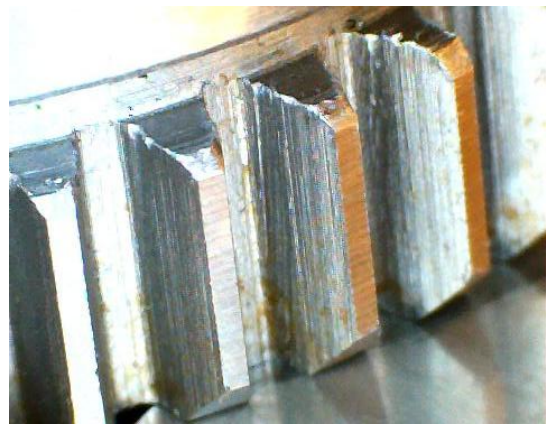
**Figure 29:** Quality of VL-6 locking system (manufacture and engagement)

On VL-6 the general quality and construction of the locking system appeared to be good. The locating holes in the locking system (for the dowels securing the carrying arm) can be seen in Figure 29.

Figure 29 shows the gear teeth and engagement achieved when using a 360° interlocking system, with no backlash in the carrying arm locking system once correctly positioned and locked.

Image (cropped): P7110017 – locking engagement

Image (cropped): test1pre\_testdot2 – quality of manufacture

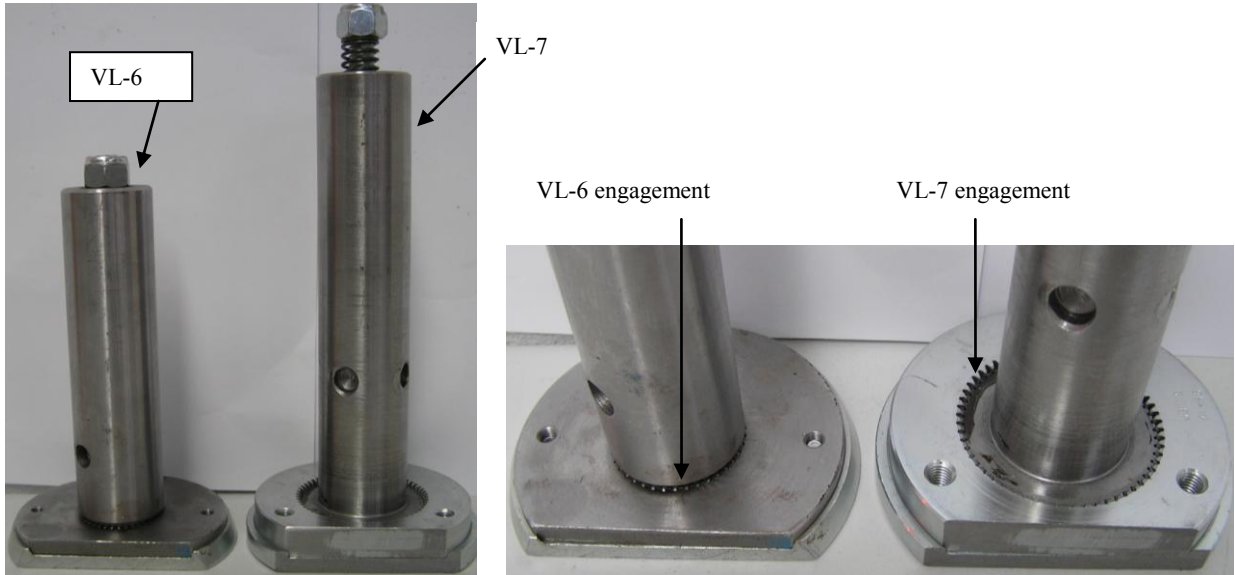
**Figure 31:** Comparison of VL-7 and VL-6 locking system

As can be seen in Figure 31, the locking system for VL-7 is approximately 1/3 larger than that of VL-6. To cope with the increase in the load carrying capability, an extra dowel has been used to secure the locking system and locating pin into the carrying arm. Similarly to VL-6, the quality of engagement was excellent, with no backlash in the gears.
