FINAL INVESTIGATION REPORT

CHEVRON RICHMOND REFINERY PIPE RUPTURE AND FIRE

CHEVRON RICHMOND REFINERY #4 CRUDE UNIT RICHMOND, CALIFORNIA

REPORT NO. 2012-03-I-CA
JANUARY 2015

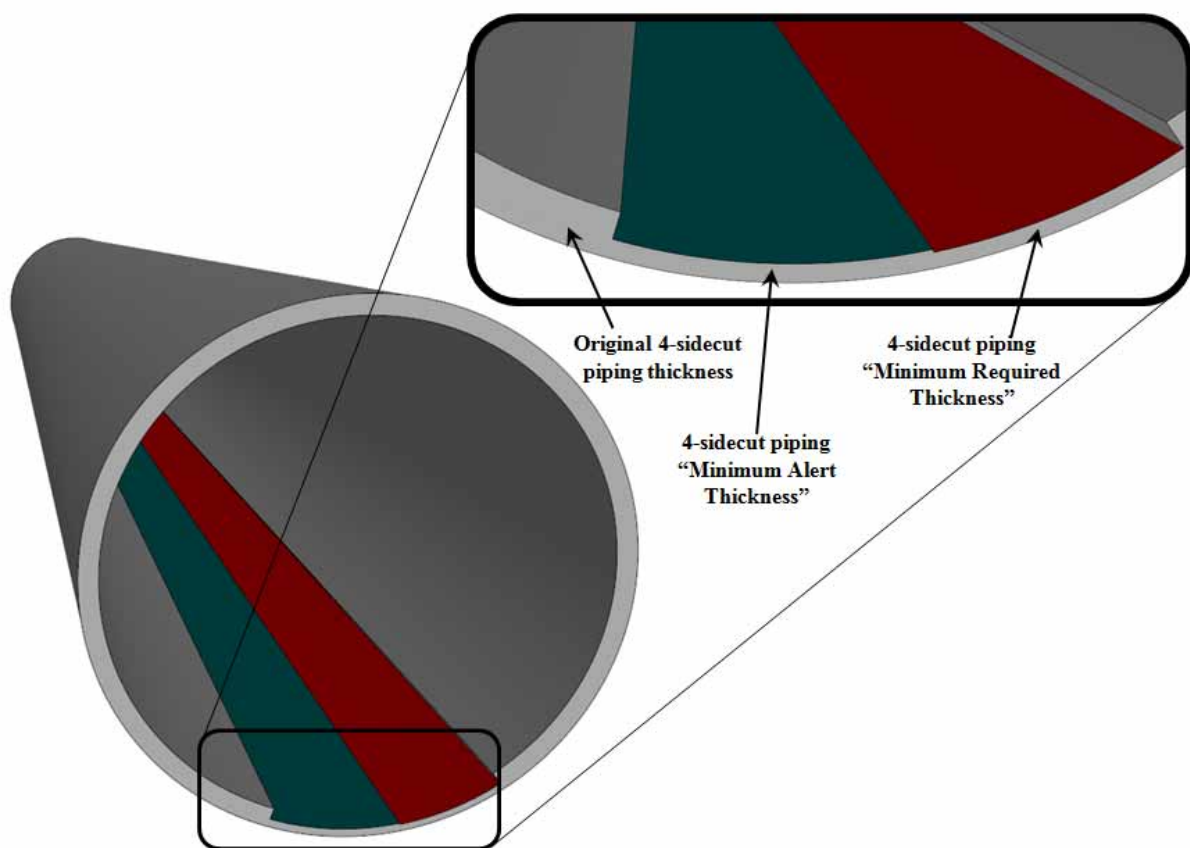
Figure 1. To-scale schematic of 4-sidecut piping identifying key wall thickness values. These include the original wall thickness (0.322-inch), “Minimum Alert Thickness” (0.13-inch), and “Minimum Required Thickness” (0.11-inch) using *API RP 574* default values.

a small piping component within the 4-sidecut piping earlier during the turnaround. This 0.036-inch value was applied to the full length of the 8-inch 4-sidecut piping circuit. This calculation was used as a technical justification to reduce the 8-inch 4-sidecut Minimum Alert Thickness to 0.1-inch, and the piping wall thickness was predicted to stay above this Minimum Alert Thickness until after the next turnaround. The 4-sidecut line was therefore allowed to continue operating with replacement scheduled for the next turnaround in 2016. *API RP 574: Inspection Practices for Piping System Components* provides users with a default minimum structural thickness of 0.11-inch for piping with a diameter of 8-inches—which can be used as the Minimum Required Thickness for piping in lieu of detailed engineering calculations.²⁹ Chevron performed a detailed calculation to determine the 4-sidecut Minimum Required Thickness and the *API RP 574* default minimum structural thickness was not used. However, had Chevron used the *API RP 574* default minimum structural thickness value of 0.11-inch as the 4-sidecut Minimum Required Thickness, the remaining life of the piping circuit would have been predicted to be less than ten years, and a turnaround planning group discussion should have been triggered to discuss replacement options for the 8-inch 4-sidecut piping. Such a discussion could have resulted in the decision to replace the 8-inch 4-sidecut piping during the 2011 turnaround, and the August 6, 2012, pipe rupture could have been prevented. In addition, Chevron does not require a formal multi-person review process to be performed to verify that available inspection data is reliable considering the relevant piping circuit damage mechanisms prior to changing the minimum thickness values used to project the remaining life of a piping circuit. (See Section 5.1.5.)

²⁹ This minimum thickness is specified for piping between 6 and 18 inches in diameter that operates at temperatures under 400 °F. The 4-sidecut piping operated at a higher temperature, likely requiring a greater minimum thickness.

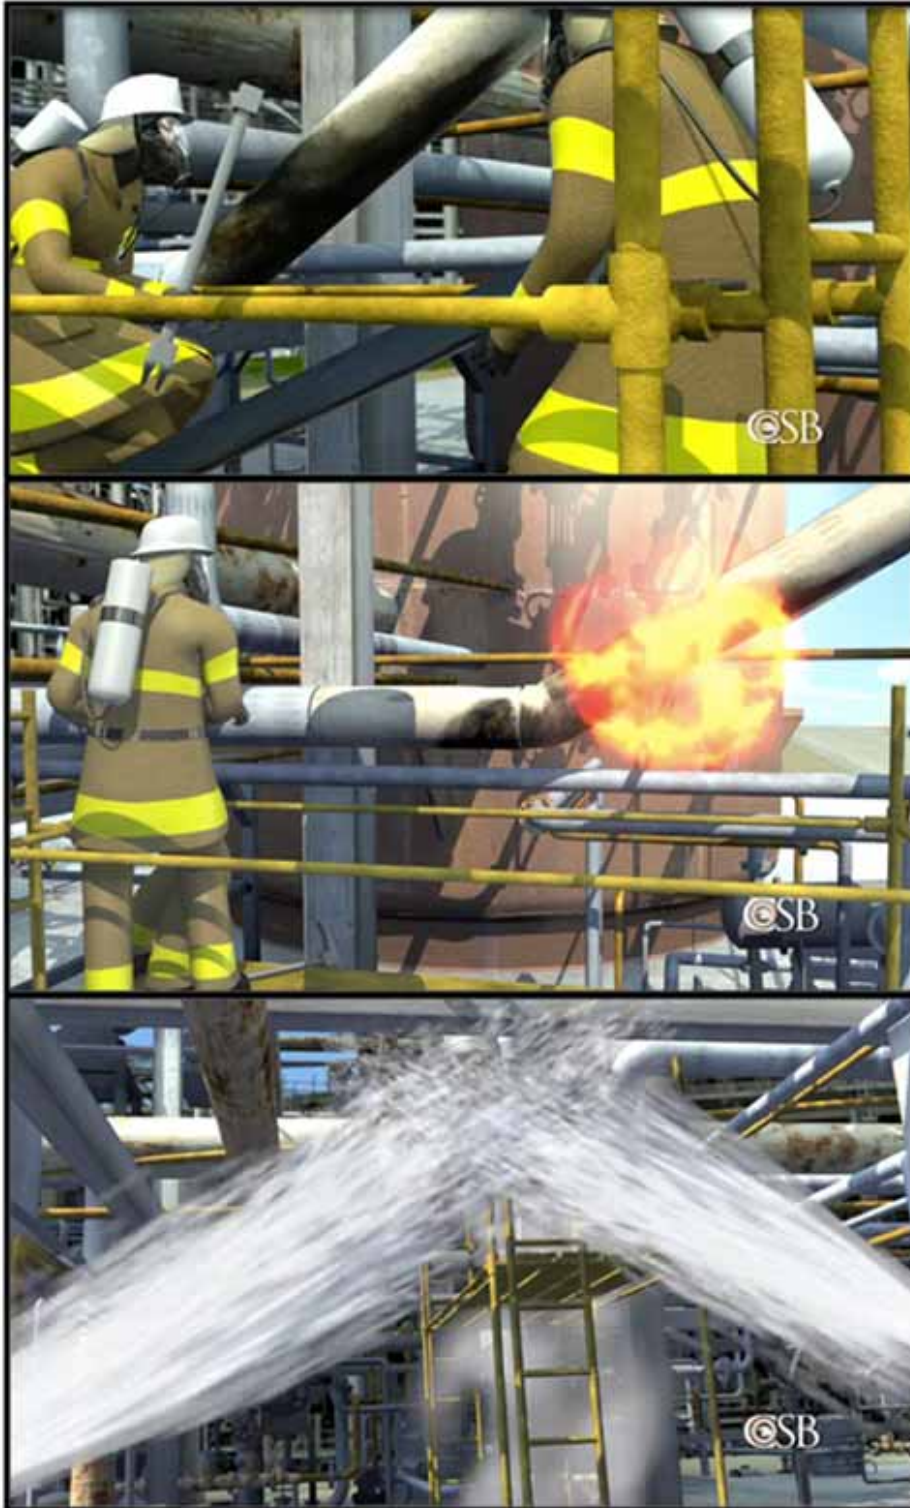
Figure 11. CSB animation of firefighters attempting to remove the 4-sidecut insulation, the resulting fire, and fire extinguishing.

As the firefighters were removing the sheathing of the 4-sidecut line (shown in Figure 7), white hydrocarbon vapor visibly began to emerge from under the now-exposed insulation material. The firefighters continued to remove the sheathing despite the formation of hydrocarbon vapor. During the continued sheathing removal, insulation that was soaked with hot 4-sidecut hydrocarbon autoignited once exposed to oxygen—only feet from the firefighters. The hose teams immediately put out the fire, and both firefighters quickly came down from the scaffold (Figure 11).

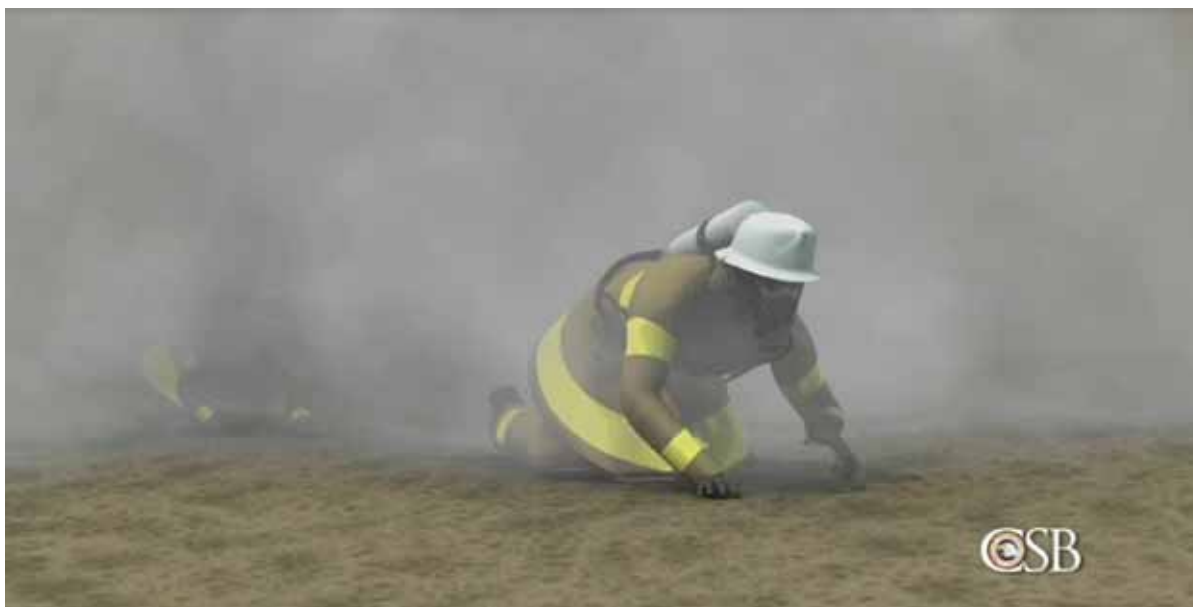
Figure 12. CSB animation of firefighters who dropped to their hands and knees to escape the vapor cloud.

Each person engulfed in the cloud began working their way out of the vapor cloud. Several of the firefighters operating the two hoses dropped to their hands and knees to follow their hose lines to safety, feeling their way out of the cloud (Figure 12).

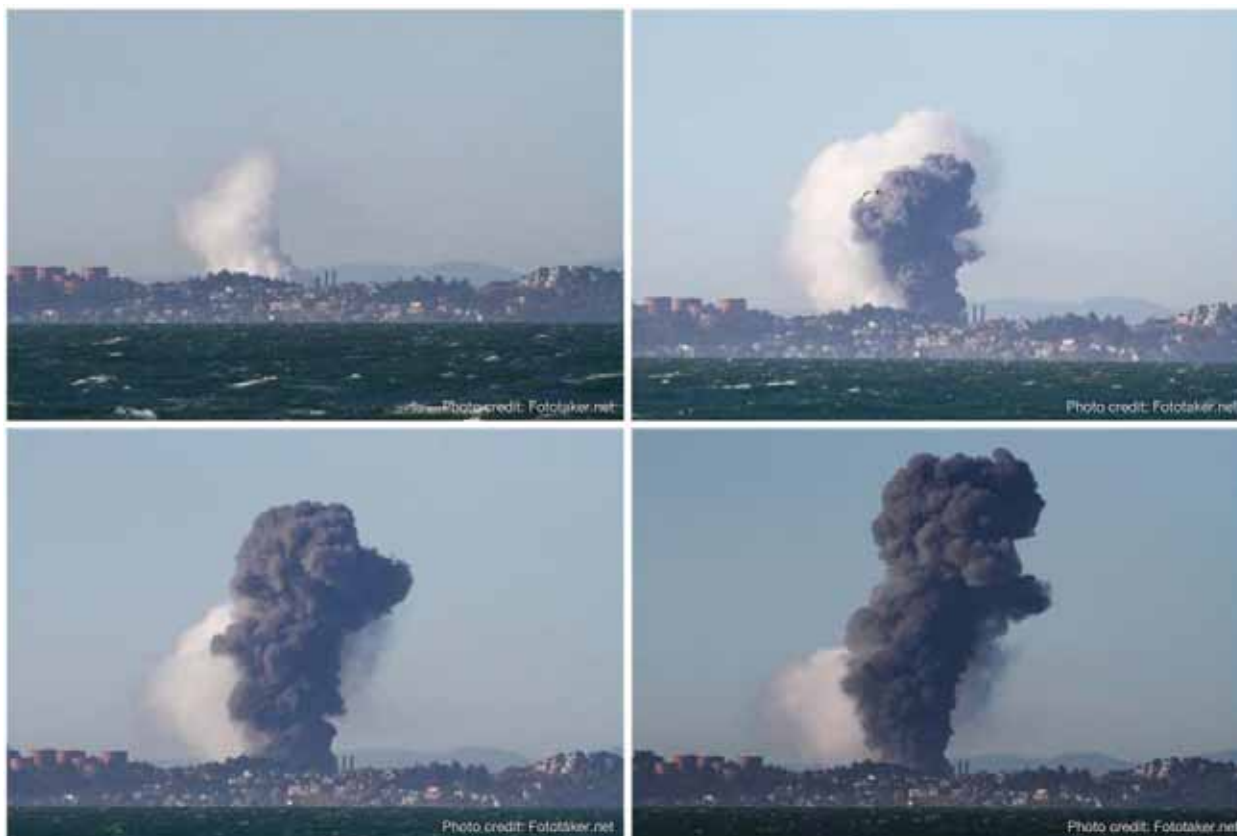
Figure 15. Initial vapor cloud formation (white cloud) and subsequent ignition (black smoke) as seen from a pier in San Francisco, California.⁵⁷

The leak resulted in a large plume of vapor which traveled across the surrounding area. The ignition and subsequent burning of the hydrocarbon process fluid created a large black cloud of smoke, which also swept across the surrounding area (Figure 15). This situation resulted in a Community Warning System (CWS) Level 3 alert,⁵⁴ and a shelter-in-place⁵⁵ advisory (SIP) was issued at 6:38 p.m.⁵⁶ for Richmond, San Pablo, and North Richmond. It was lifted later that night at 11:12 p.m. after the fire was fully under control. In the weeks following the incident, nearby medical facilities received over 15,000 members of the public seeking treatment for ailments including breathing problems, chest pain, shortness of breath,

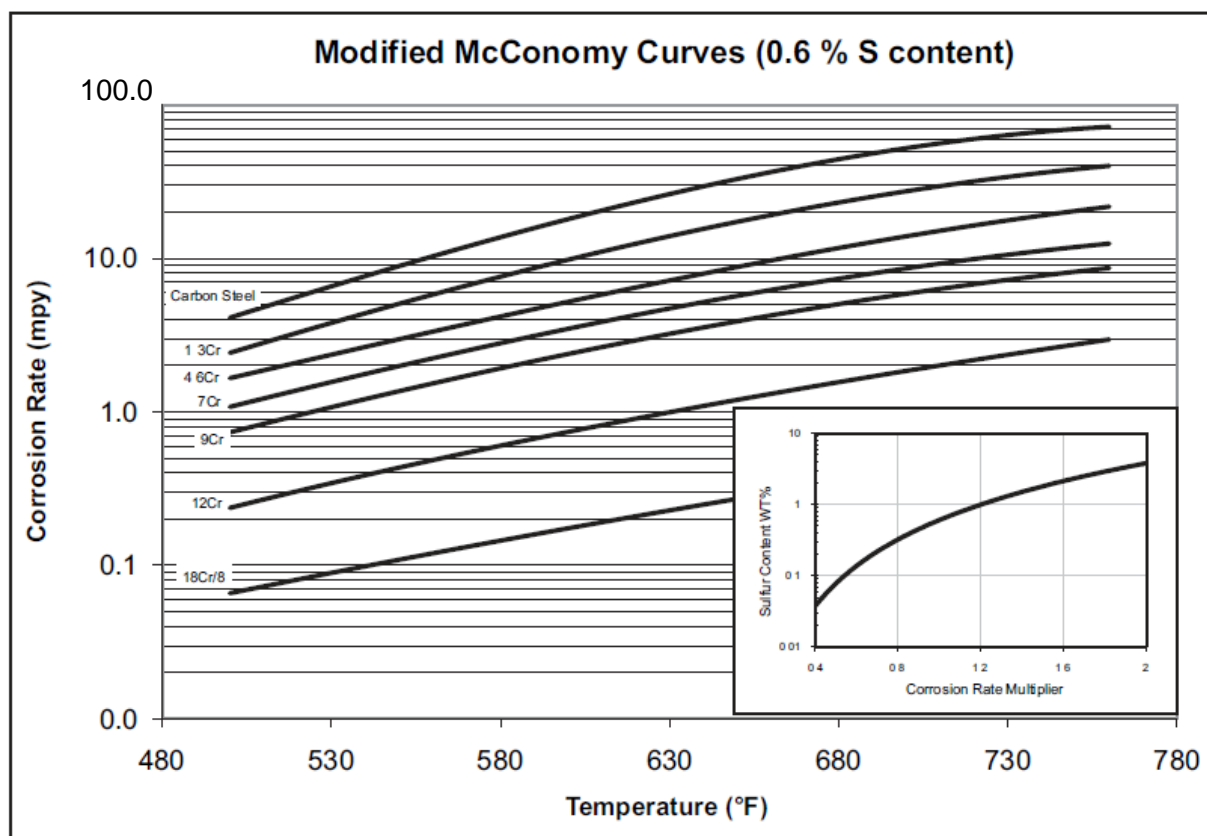
Figure 22. Modified McConey Curves from API RP 939-C.

greatly reduced. Carbon steel⁹⁹ corrodes approximately nine times faster than 9-Chrome steel, which contains 9 percent chromium, and carbon steel corrodes approximately 120 times faster than stainless steel, which contains 18 percent chromium.^{100,101}

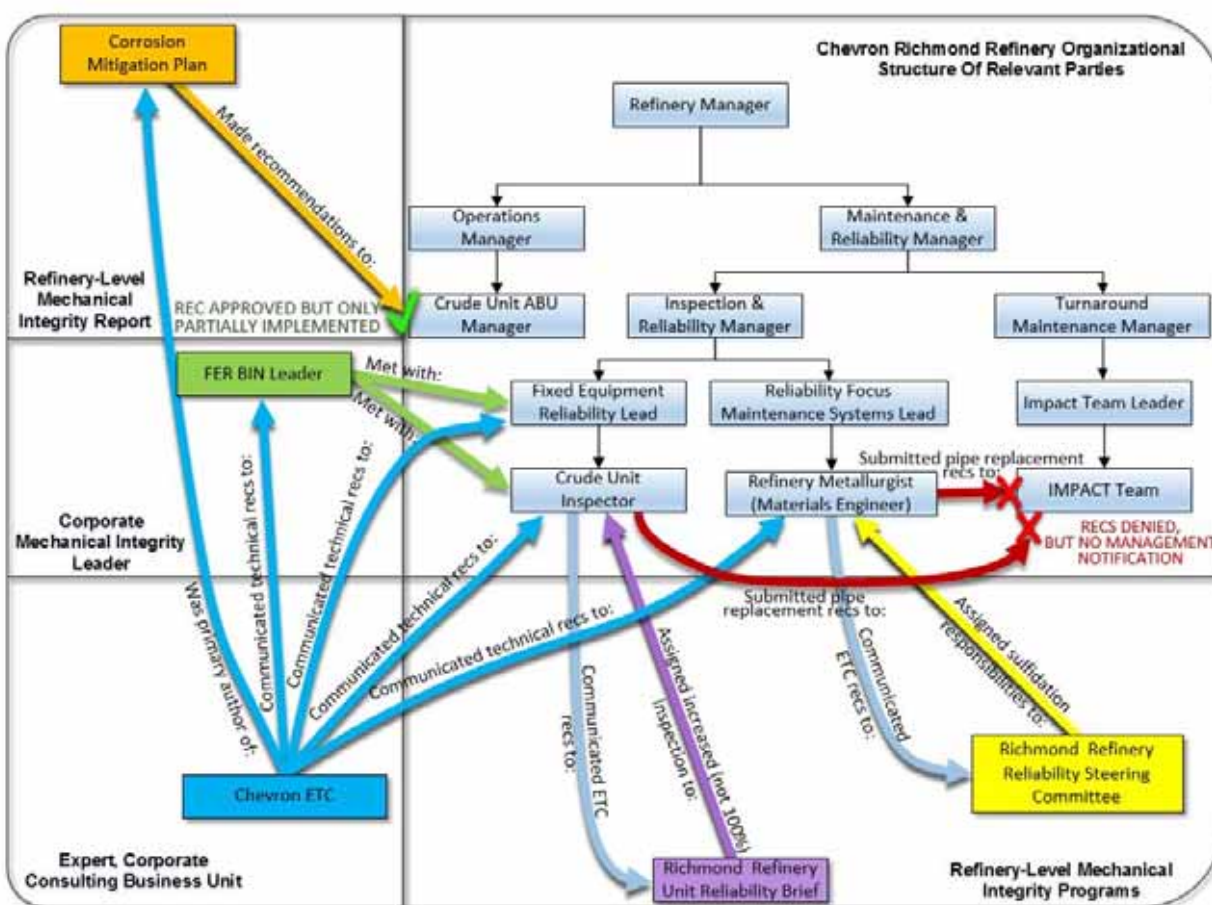
In the ten years prior to the incident, a small number of Chevron personnel with knowledge and understanding of sulfidation corrosion made recommendations to increase inspections or upgrade the material of construction in the 4-sidecut piping. Their recommendations were not effectively implemented. The process to implement important, safety-critical projects within the Chevron Richmond Refinery was not fully effective. As discussed in the following sections and depicted in Figure 25, a combination of (1) reliance on a turnaround management program that depended on only a fraction of necessary data to make important process safety decisions, (2) an unsuccessful bottom-up approach—with no management oversight or accountability—for implementing a crucial safety program, and (3) no formal method to track to completion the Chevron expert group's findings and recommendations ultimately caused these recommendations to not be implemented.

Figure 25. Organizational decision-making schematic showing attempts to have carbon steel 4-sidecut piping 100 percent component inspected or replaced with a higher chromium steel alloy. Attempts failed due to lack of accountability and lack of authority to ensure recommendation implementation, and a rigid turnaround planning process that could not approve the 4-sidecut piping replacement recommendations.

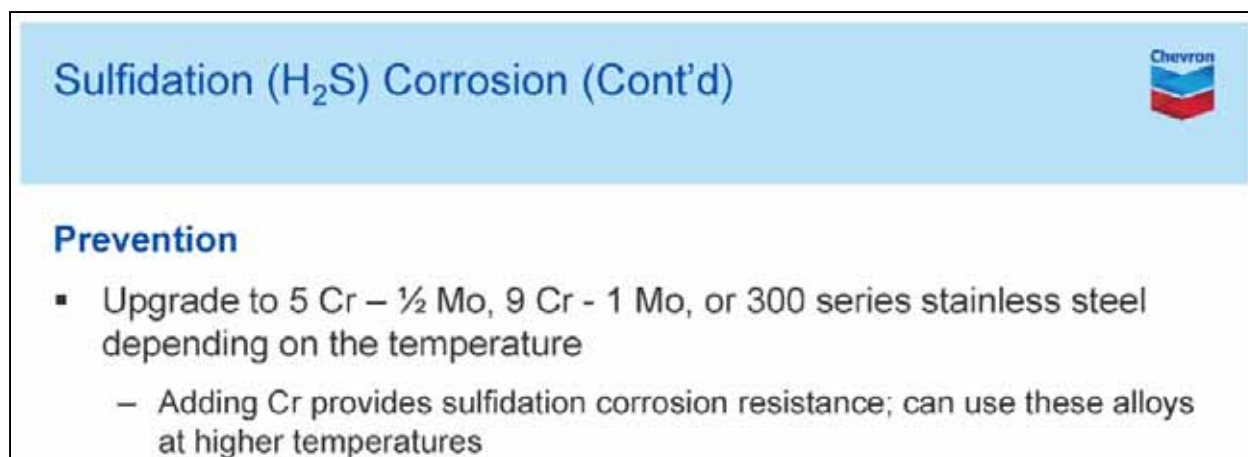
Figure 29. Presentation slide of ETC training course that guided refinery staff to perform 100 percent component inspection on high-temperature lines susceptible to sulfidation corrosion.

Chevron ETC also regularly hosted training sessions for refinery personnel. One of these classes, designed for refinery inspection staff but also attended by refinery engineers and senior operators, focused specifically on crude units and on corrosion mechanisms within crude units—including sulfidation corrosion. One of the main messages from this training was that sulfidation corrosion in piping containing low-silicon components can result in catastrophic rupture, and that the means to prevent rupture from occurring is performing 100 percent component inspection or upgrading to a higher chromium steel (Figure 29 and Figure 30).

- Small amounts of Si greatly reduce sulfidation rate
- A106 pipe requires 0.10 wt % min. Si, but A53 pipe does not require Si
- Most A53 piping also contains Si so there are very few isolated piping components with low Si
- Result: Sulfidation may be “localized” to an individual component, while TML's are likely to be on higher Si components
- Recommendation for CS >500°F (260°C): Inspect every component in piping system once to confirm they are corroding at the same rate; thereafter, just monitor a few (as usual)

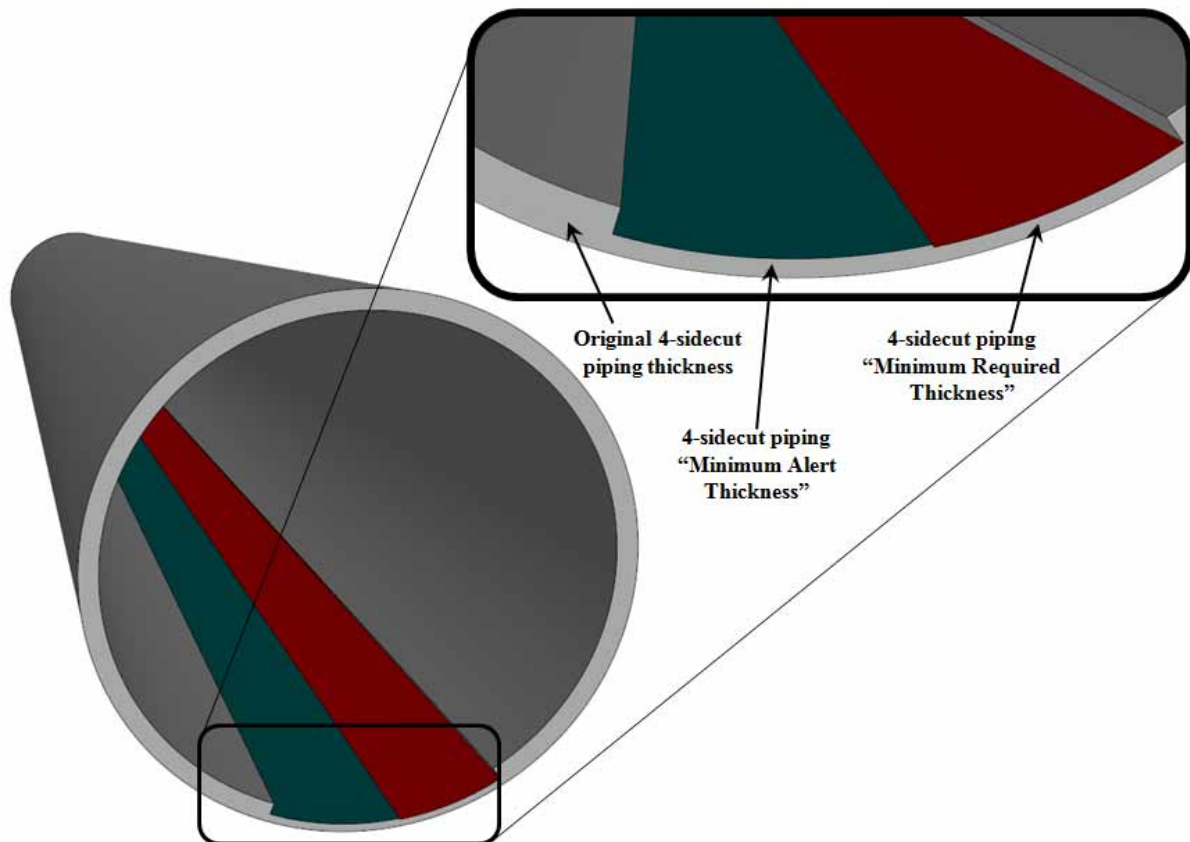
A visual depiction of the 4-sidecut original wall thickness, its Minimum Alert Thickness, and its Minimum Required Thickness appears in Figure 36.

Figure 36. To-scale schematic of 4-sidecut piping original wall thickness (0.322-inch), Minimum Alert Thickness (0.13-inch), and Minimal Required Thickness (0.11-inch) using *API RP 574* default values.

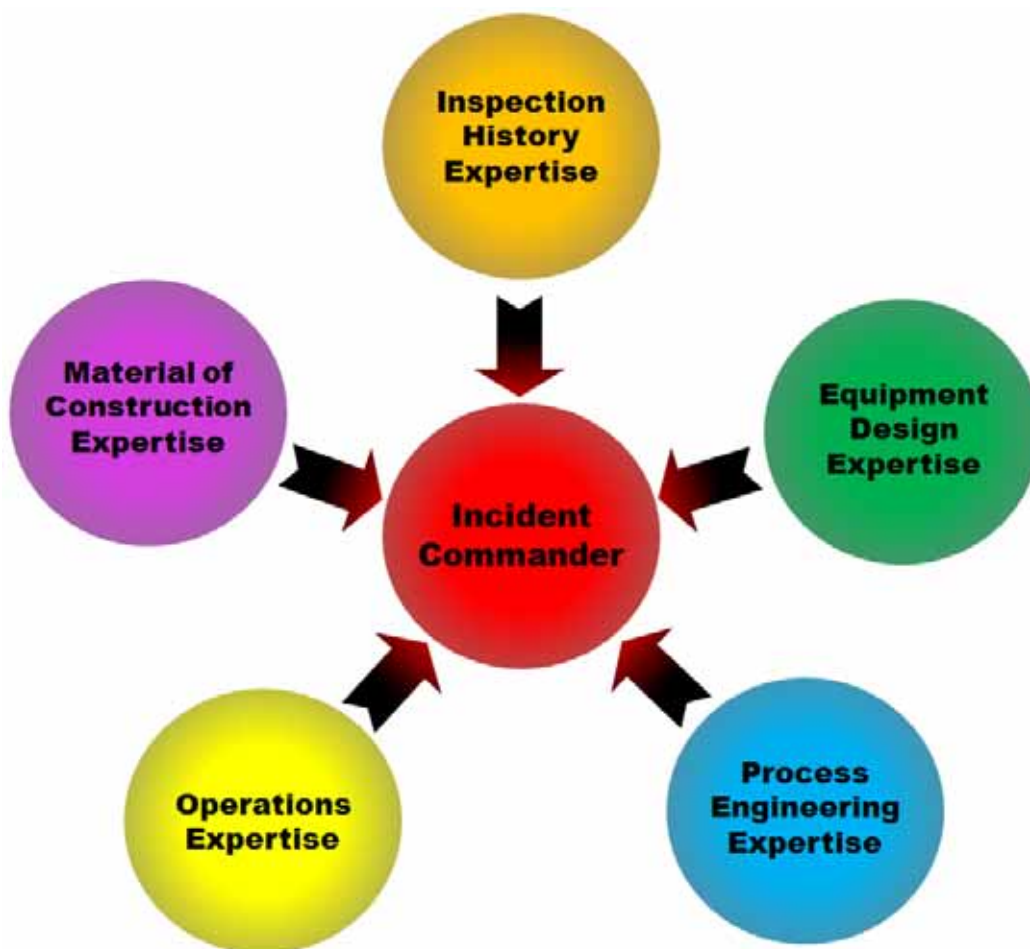
Figure 42. Ideal communication flow to Incident Commander during refinery process fluid leak incident. In industrial process fluid leak emergency situations, it is essential that various personnel with different areas of expertise communicate their relevant knowledge to the Incident Commander.
